ASSESSMENT REPORT

OKOBOJI CSD

OKOBOJI, IOWA

FEH DESIGN

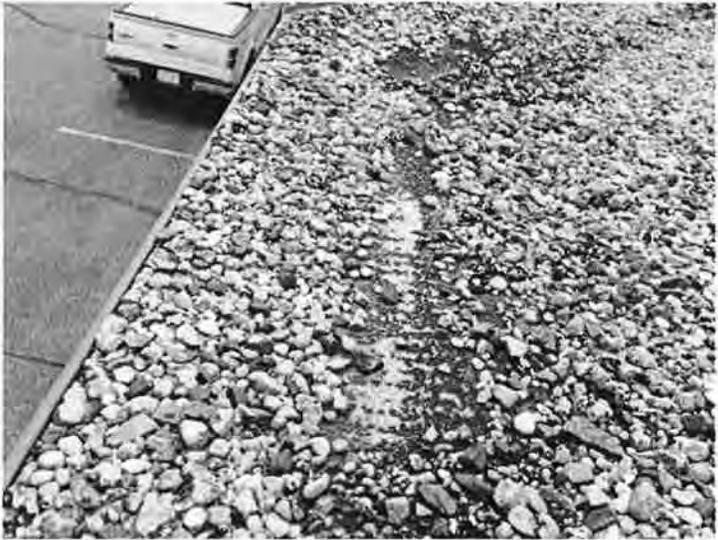
Exposed Felts (Common)

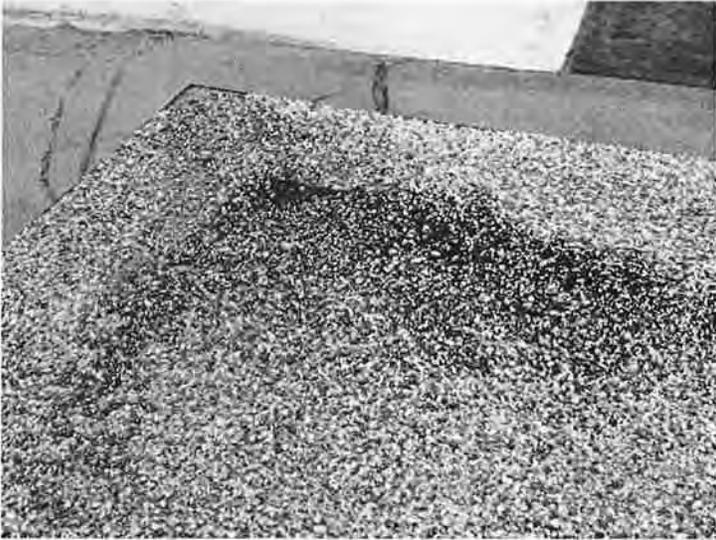
Deteriorating Asphalt at the Field Felts

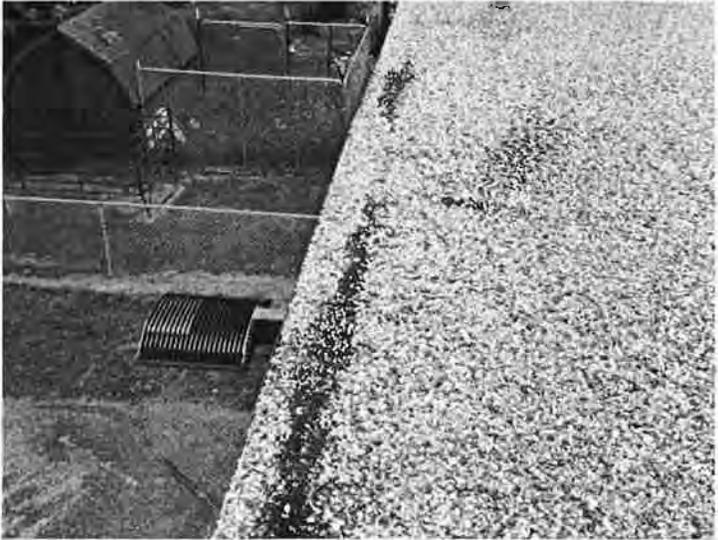
Deteriorating Asphalt at the Field Felts

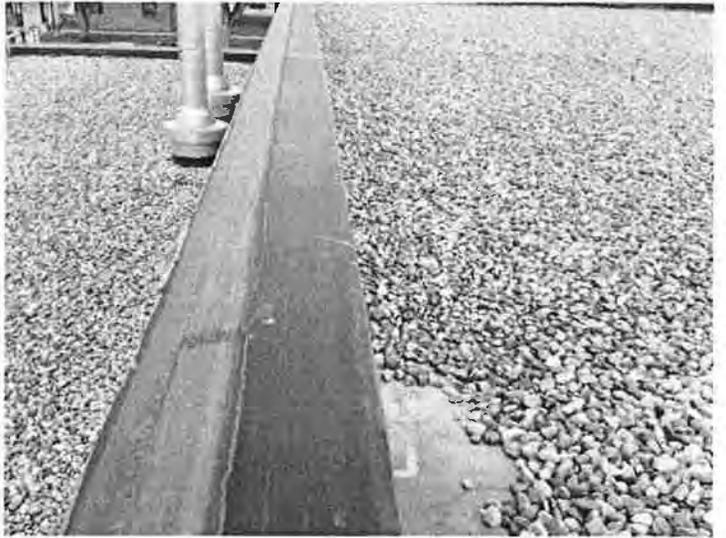
Suspect Wall Flashing Detail

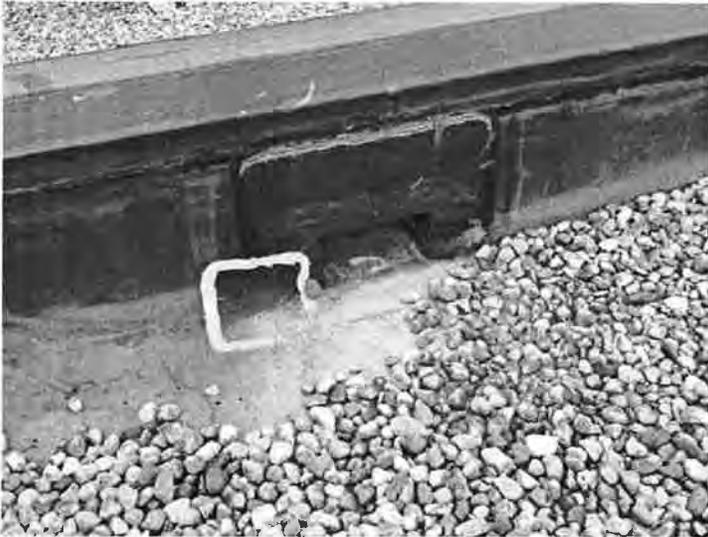
Repaired Scupper Details Holding Well

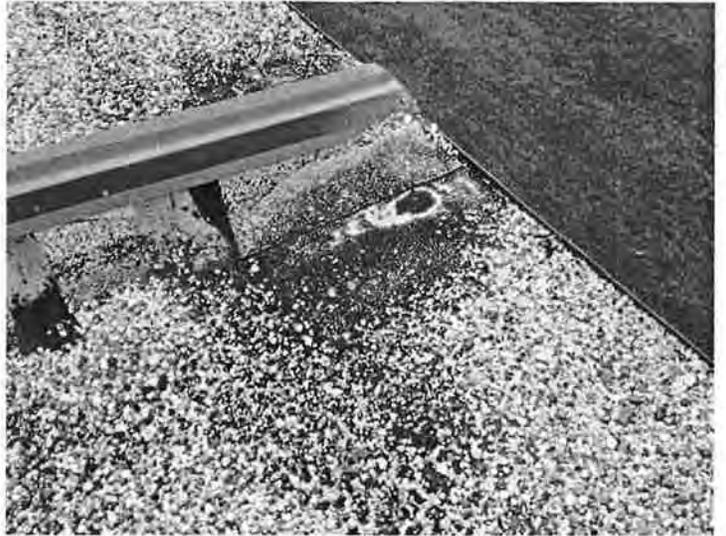
Cracked Wall Flashings

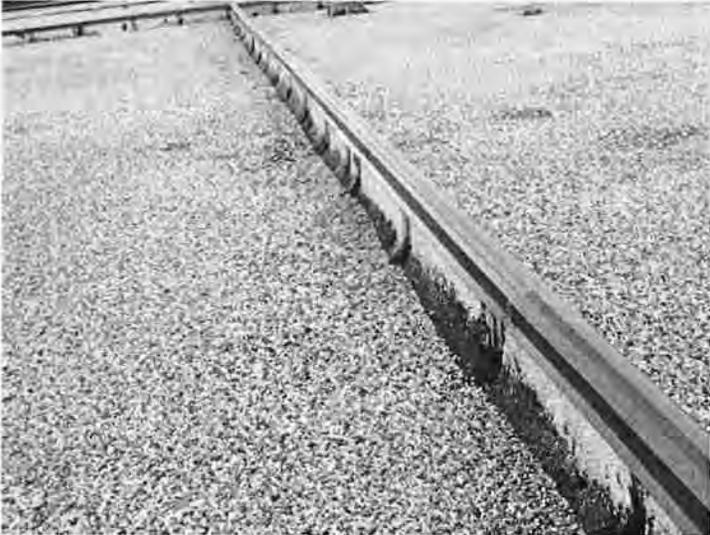
Wall Details Deteriorating But Holding

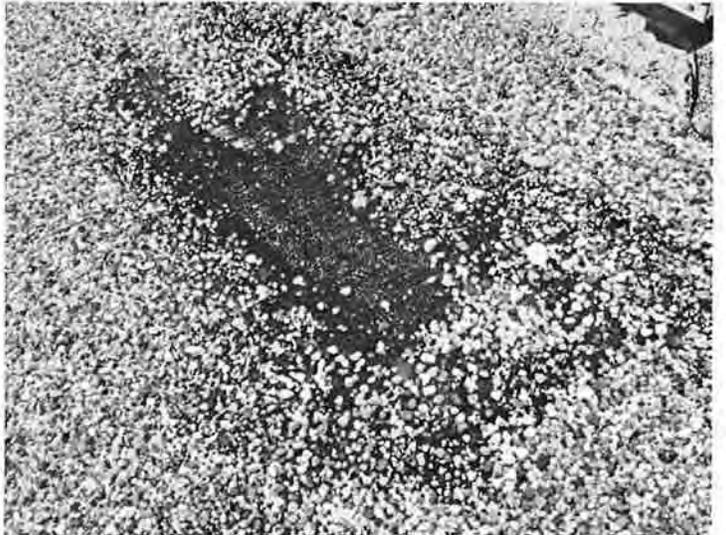
Bare Spots Appear Around Field

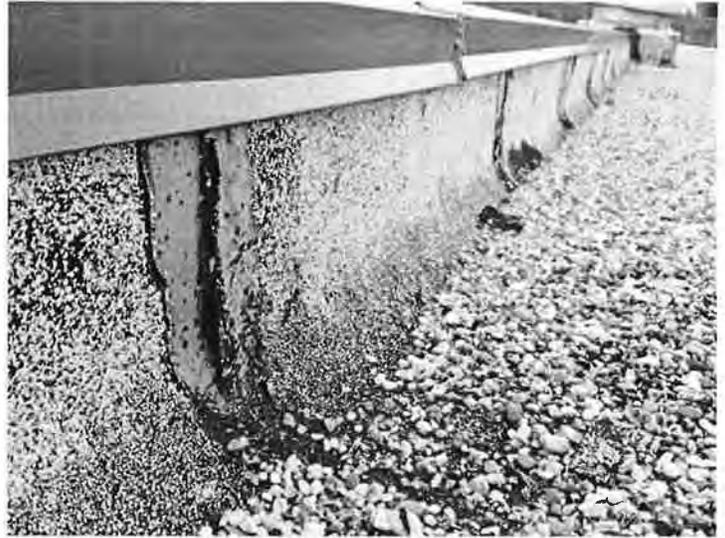
Wall Seam Repairs Beginning to Separate

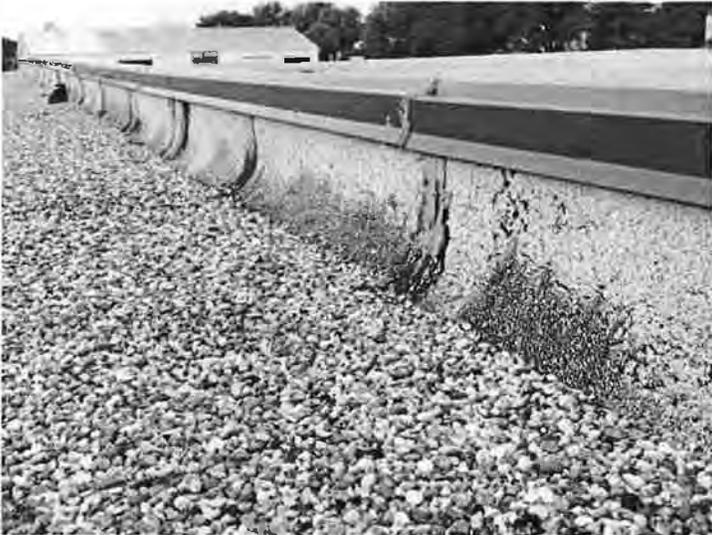
Wall Flashings Holding for Their Age

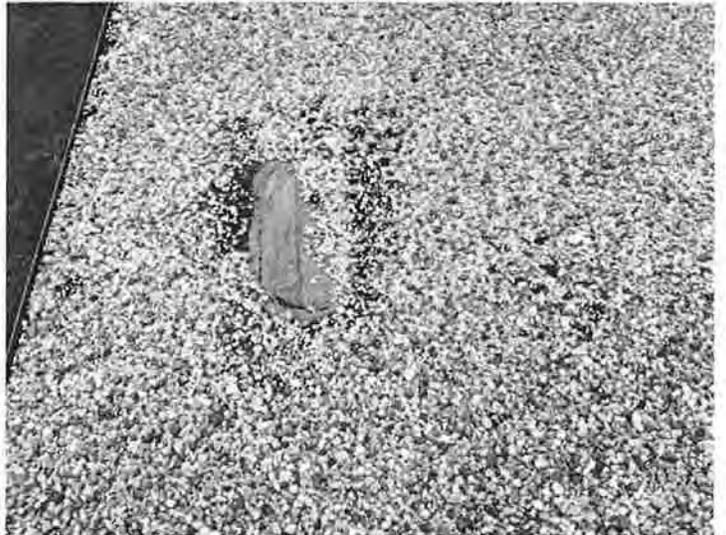
Previously Repaired Area Holding But Deteriorating

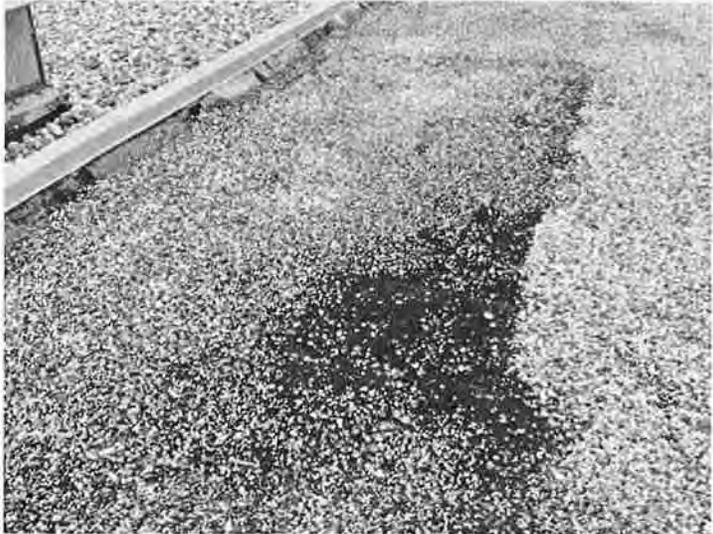
Field Deterioration (Common)

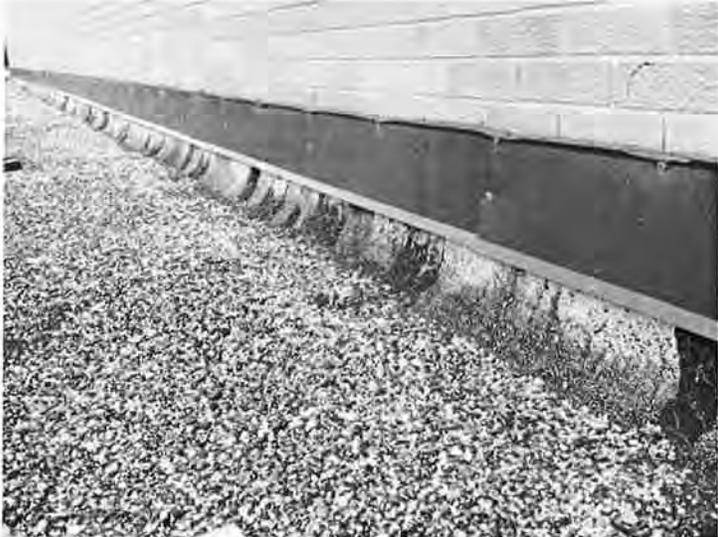
Moderately Deteriorated Wall Flashing

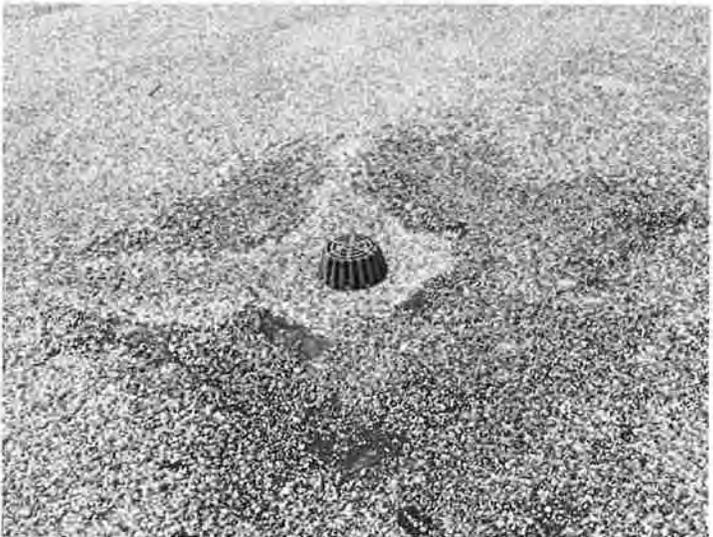
Field Deterioration Around Drain

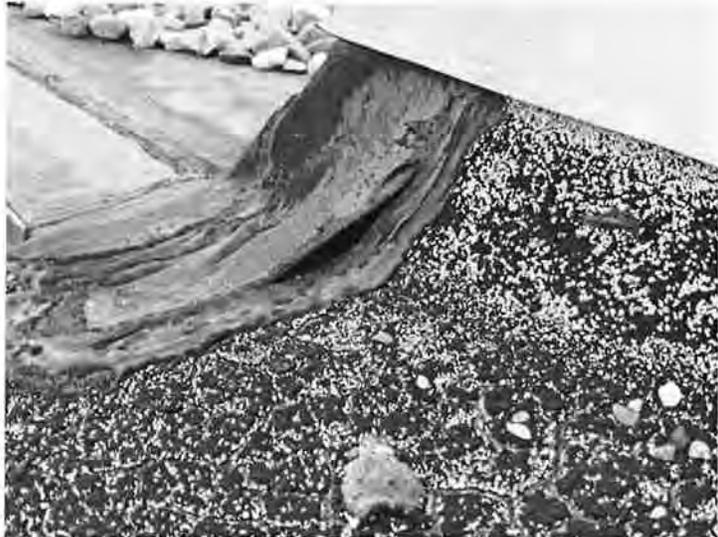
Past Repairs Now Deteriorating

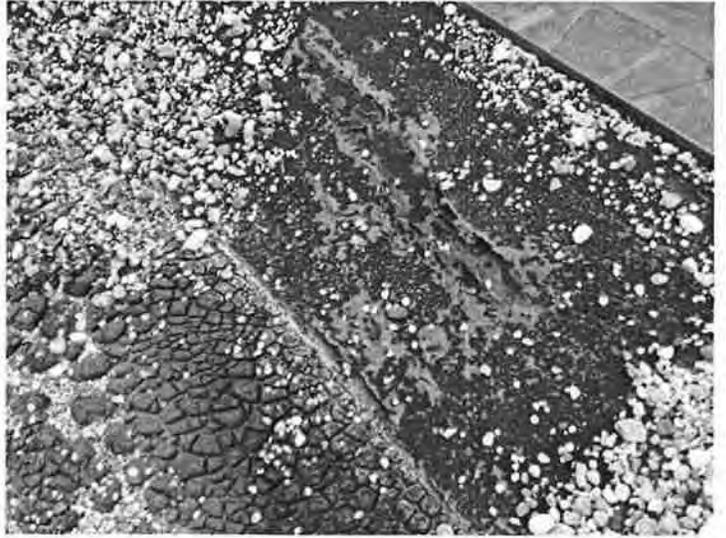
Large Bare Spots

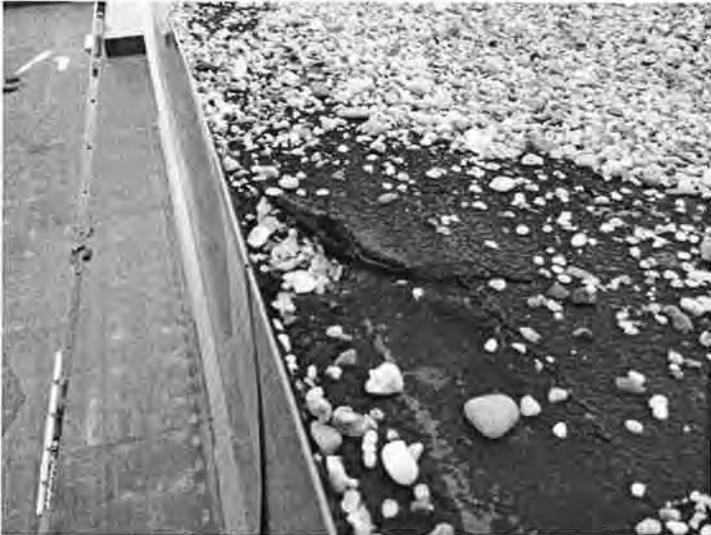
Perimeter Edge Very Deteriorated (All Sides)

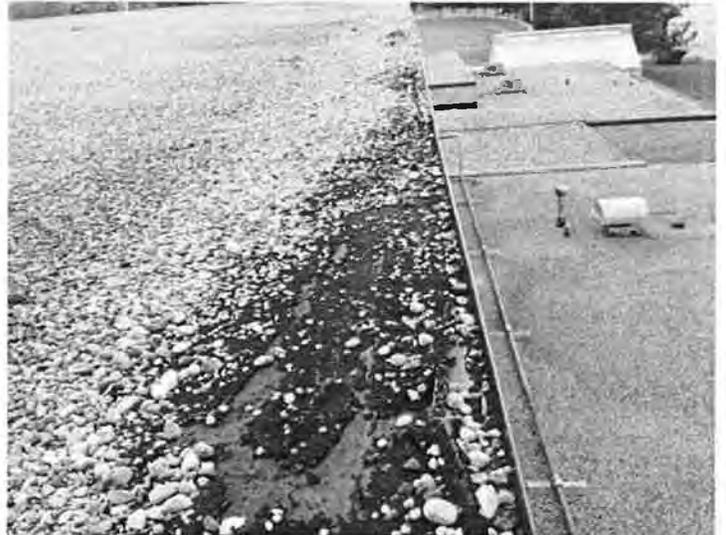
Perimeter Edge Very Deteriorated (All Sides)

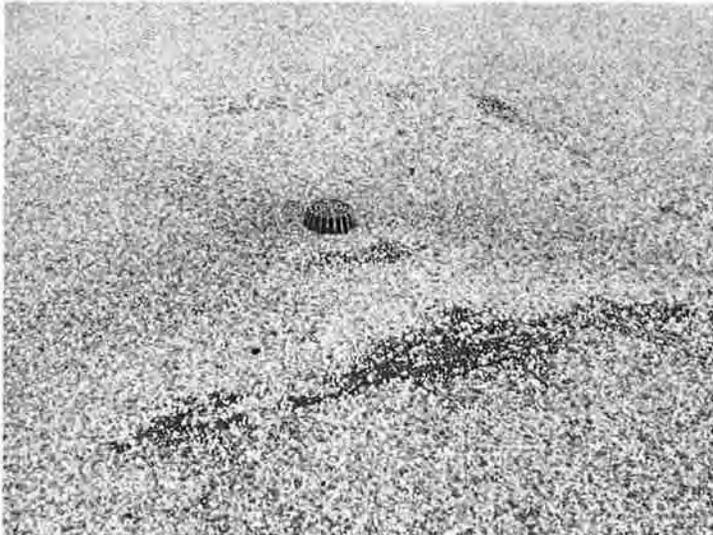
Drain Details Deteriorated Exposing Felts

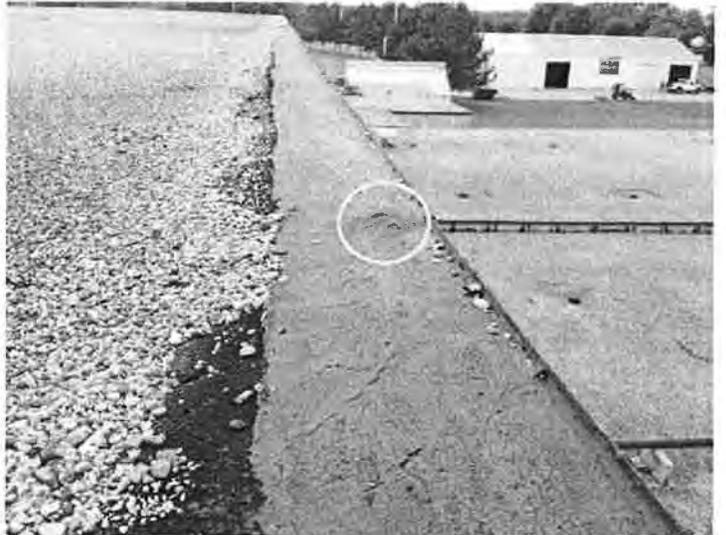
Past Perimeter Repair Now Starting to Fail

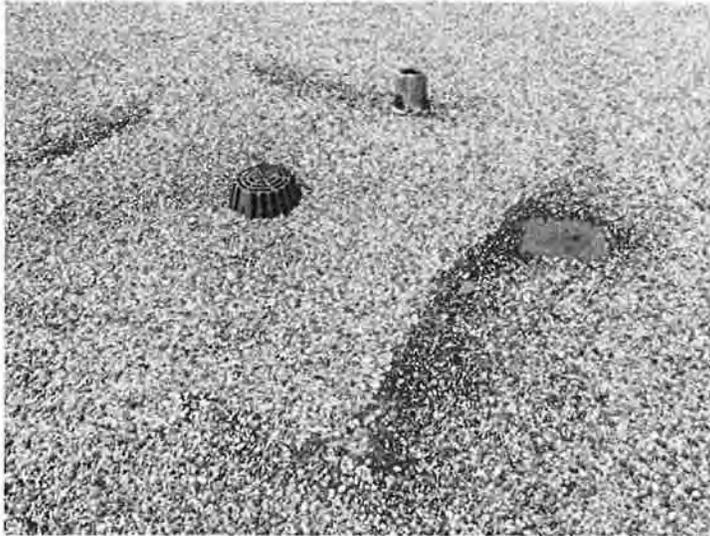
Bare Spots at Drain Details

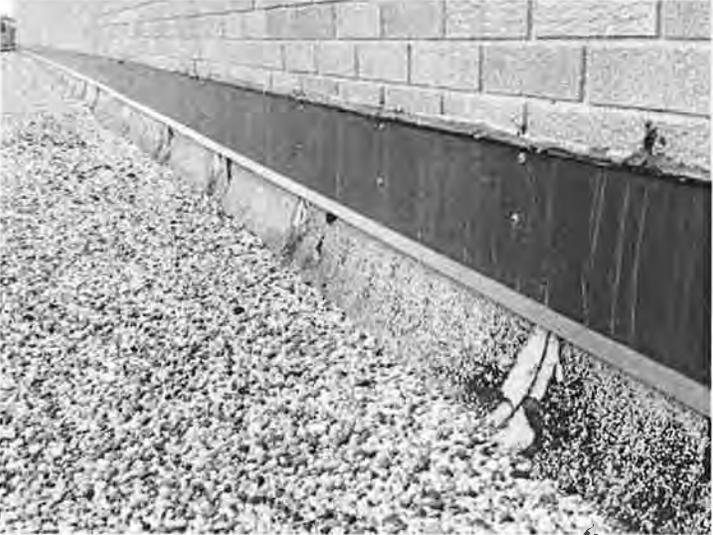
Deteriorated Wall Flashing

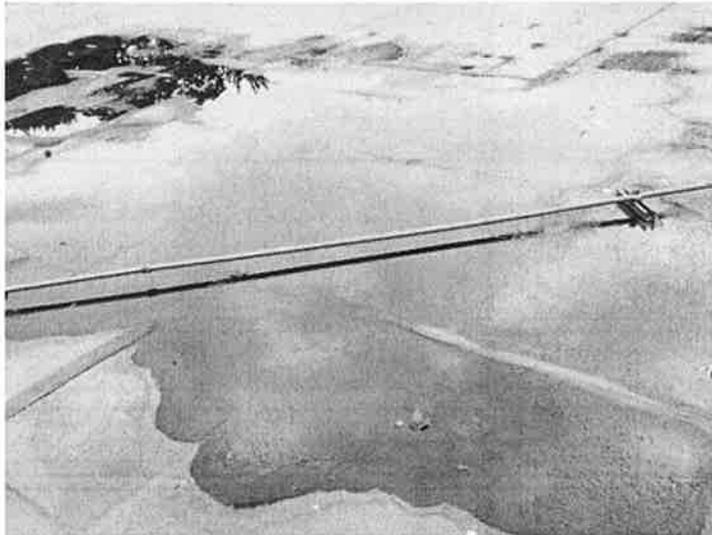
Pooling in Field

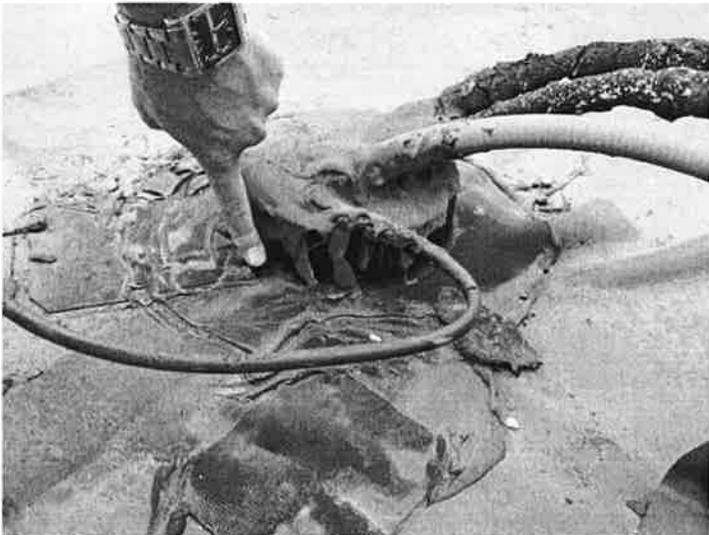
Open Flashing At Pitch Pan Likely Leak Source

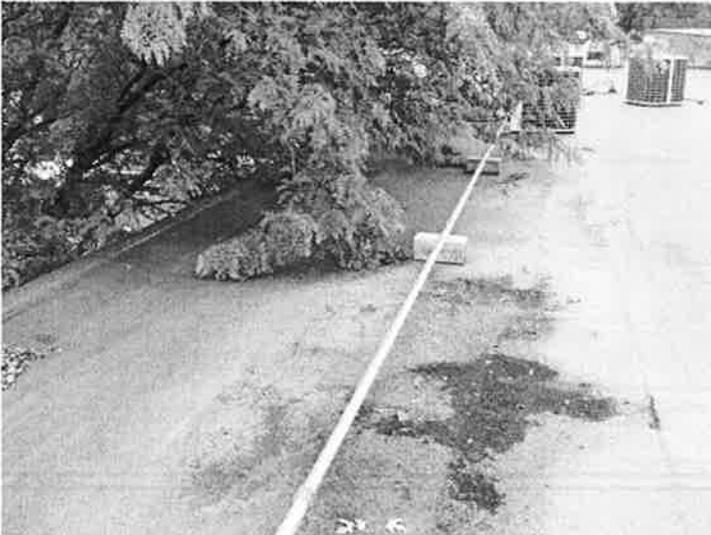
Tree Overhanging Roof

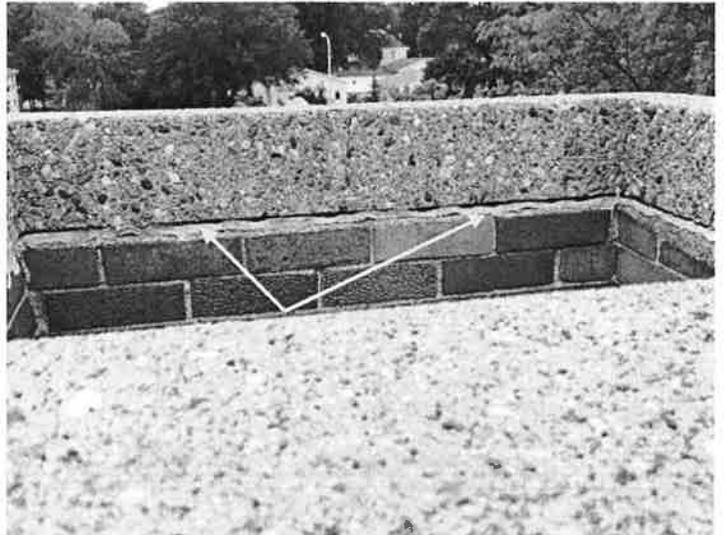
Deteriorated Sealant at Inside of Chimney

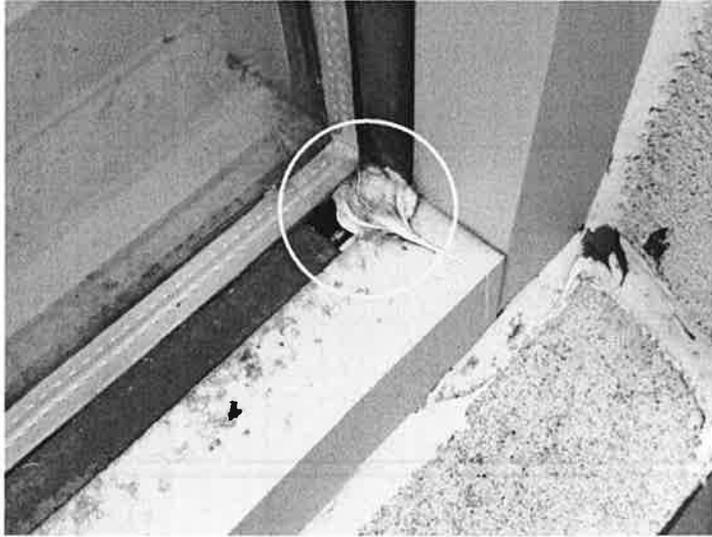
Likely Leak Source (Gap In Corner Window Glazing)

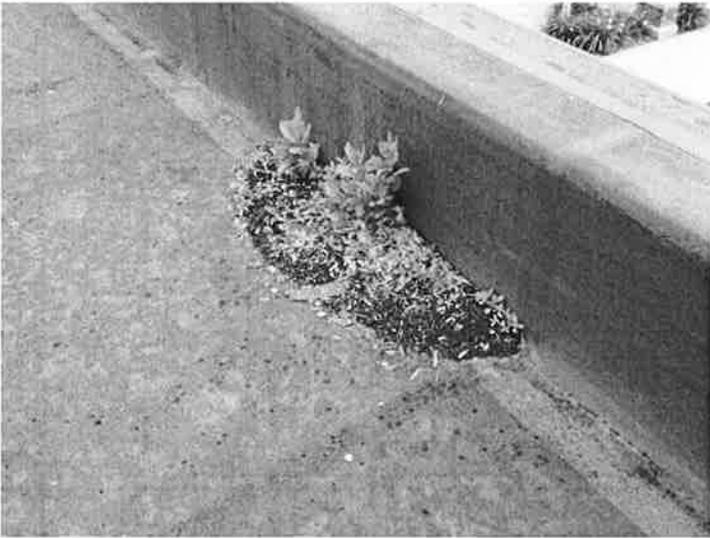
Vegetation Growth

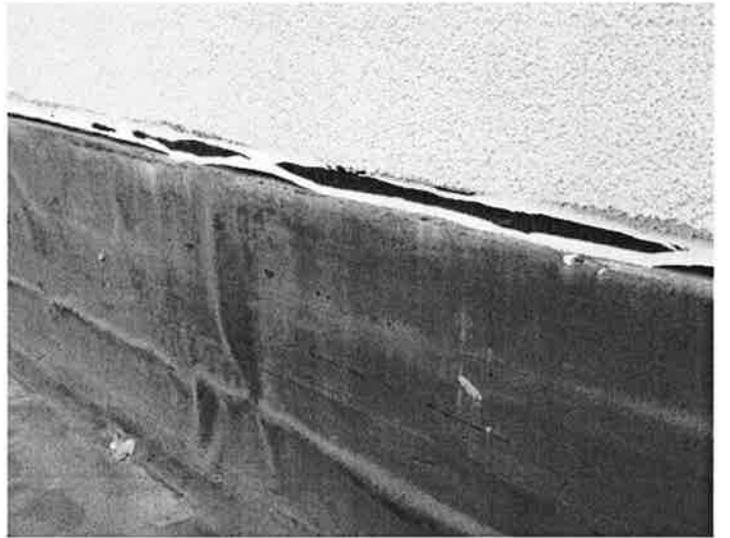
Joint at EIFS Failing
