ASSESSMENT REPORT

OKOBOJI CSD

OKOBOJI, IOWA

FEH DESIGN

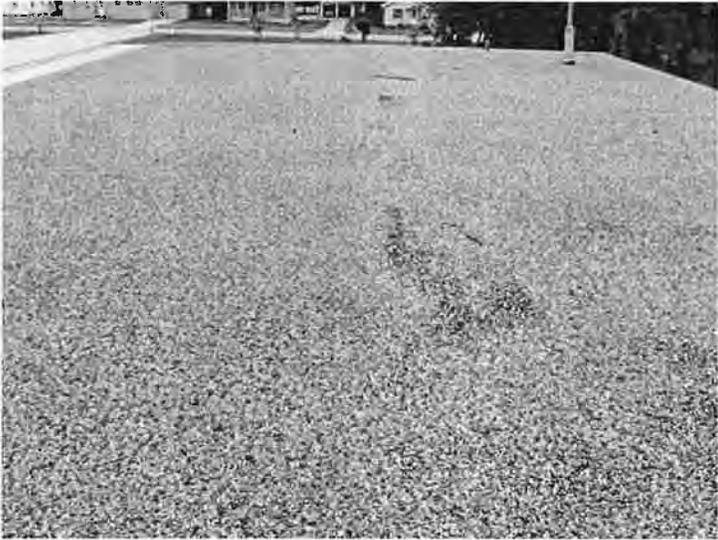
Exposed Felts (Common)

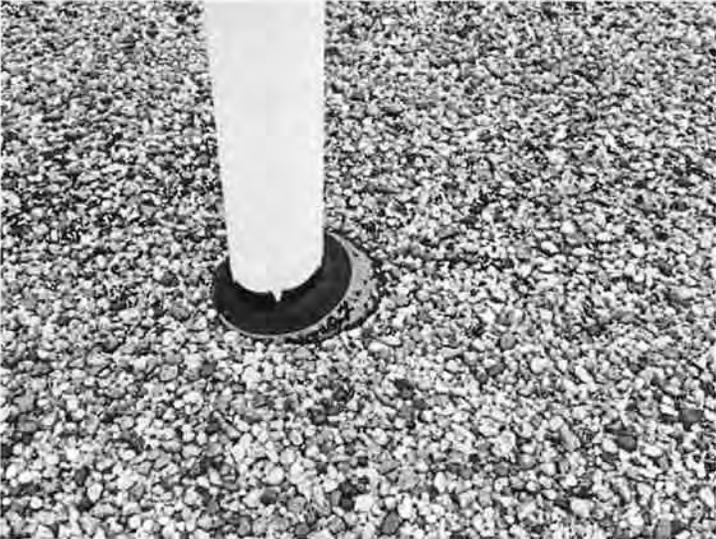
Gutter Detail (Minor Debris/Ponding)

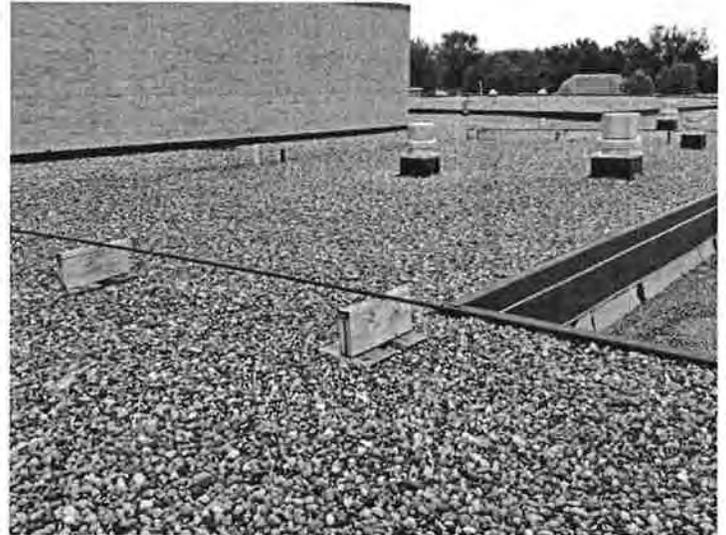
Minor Pulled Vertical Wall Flashing

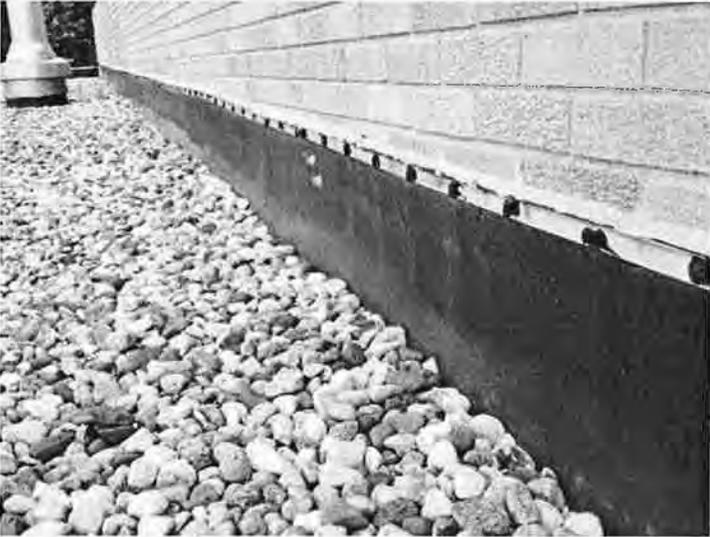
Moderate Pulling Along West Wall

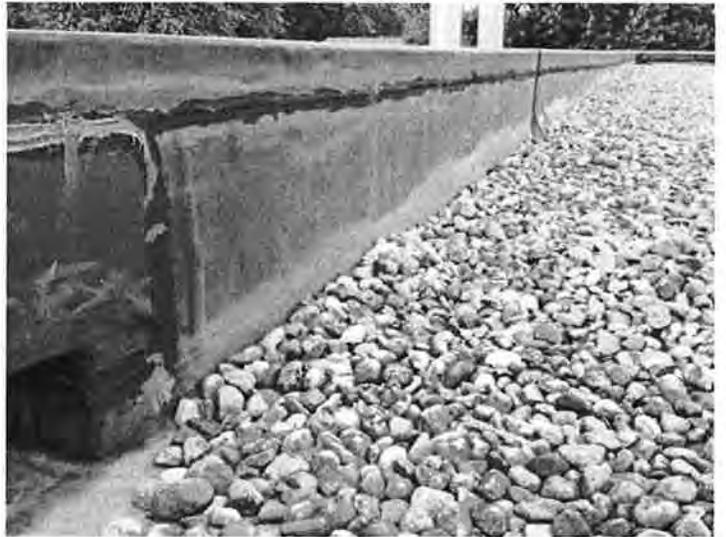
Significant Lifting at West Wall Flashing

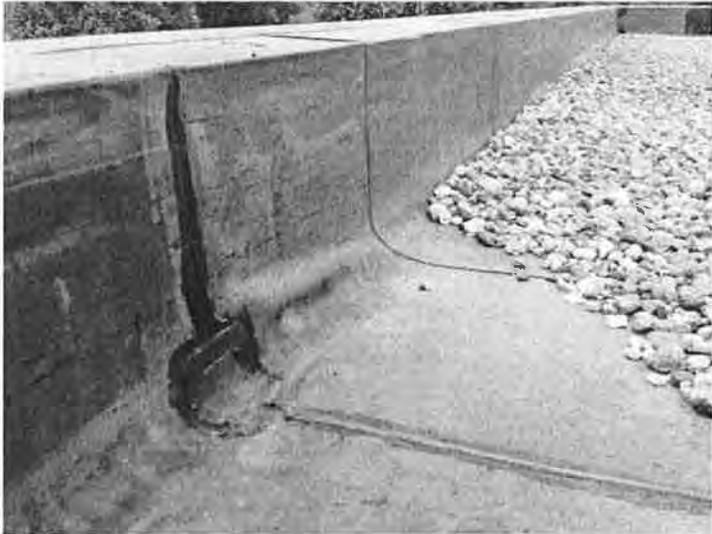
Moderate Pulled Wall Flashing (60°)

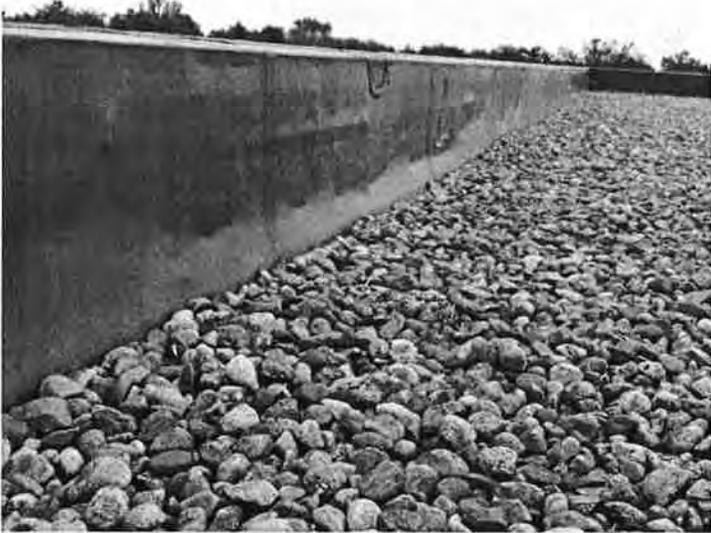
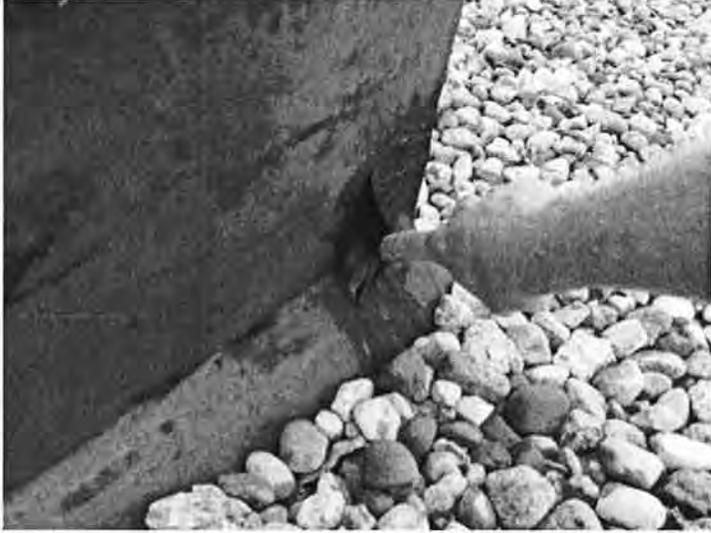
Open Curb Corner Flashing

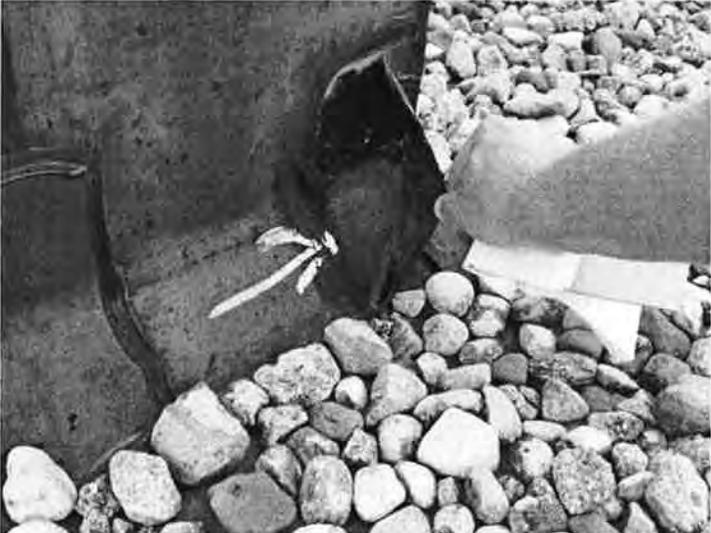
Lifting Field Seam

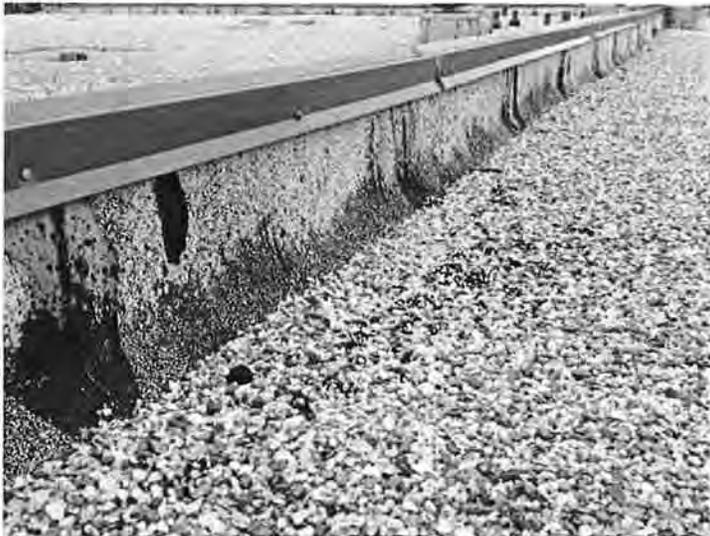
Exposed Felts at Drain Details

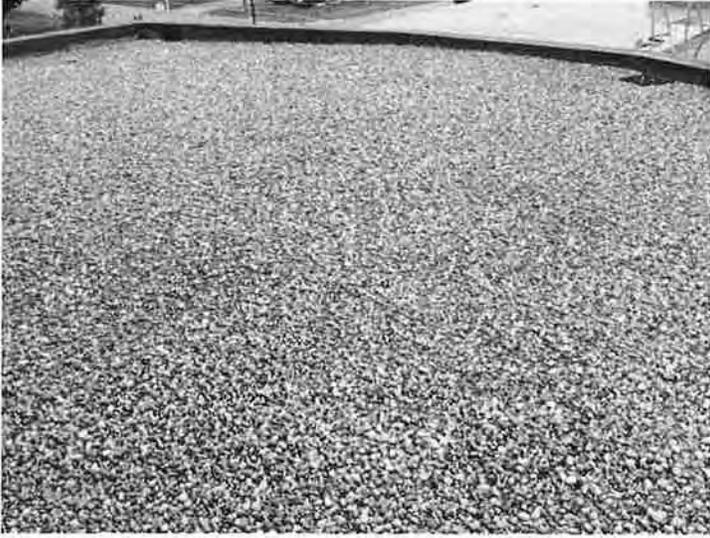
Roof Overview Section 8

Section 8 is in fair condition. The roof is evenly ballasted and free of debris. There are two walls with moderate pulling of the wall flashings.

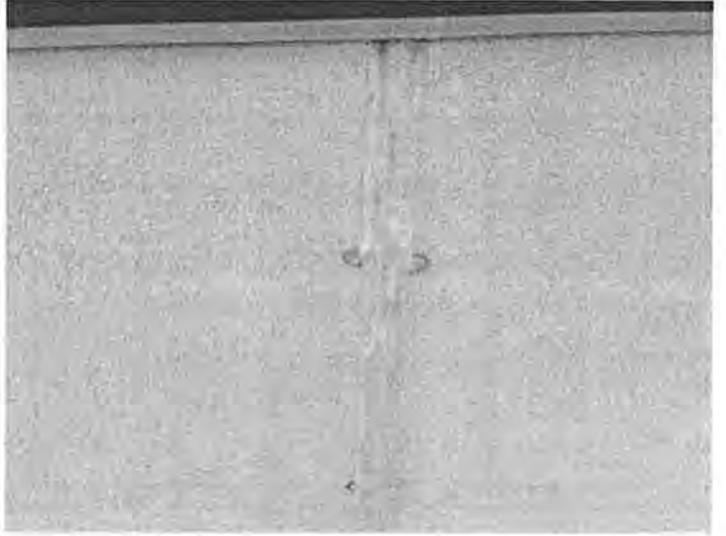
EIFS Joints Have Been Sealed

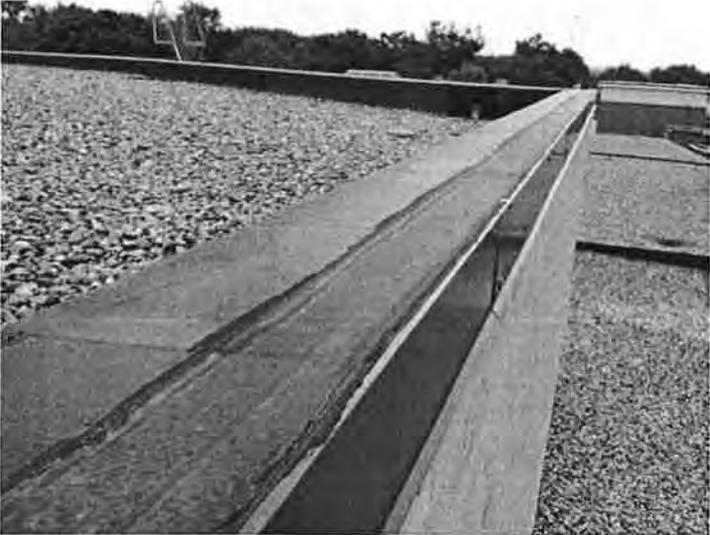
Roof Edge Looks Good

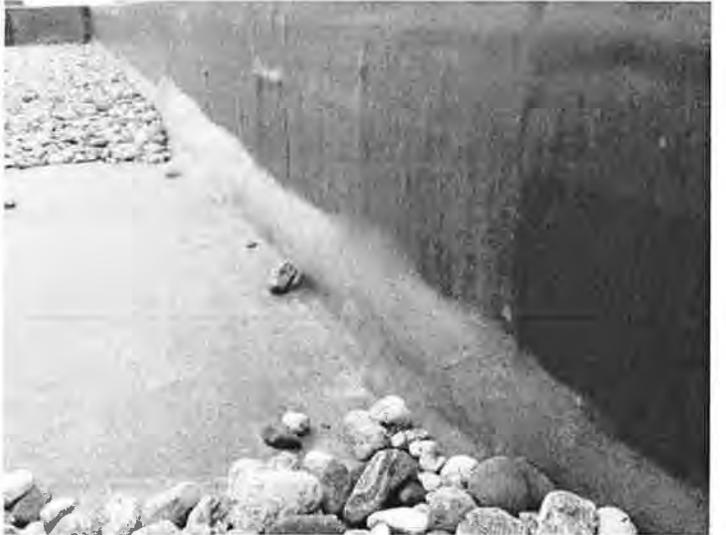
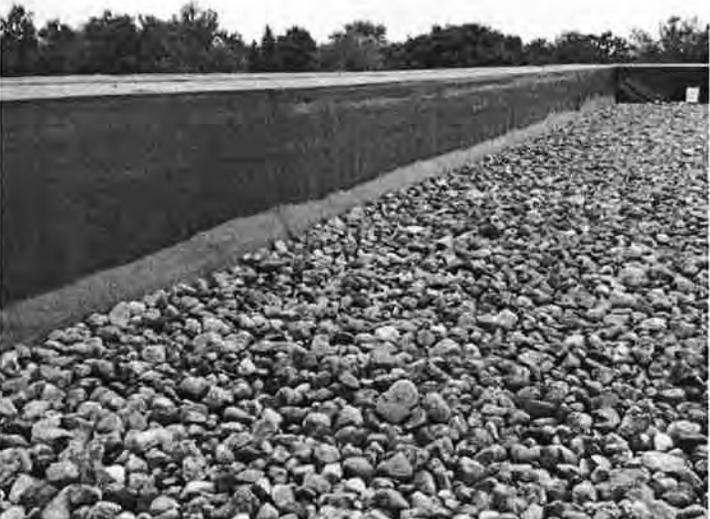
Moderate Pulled Wall Flashings

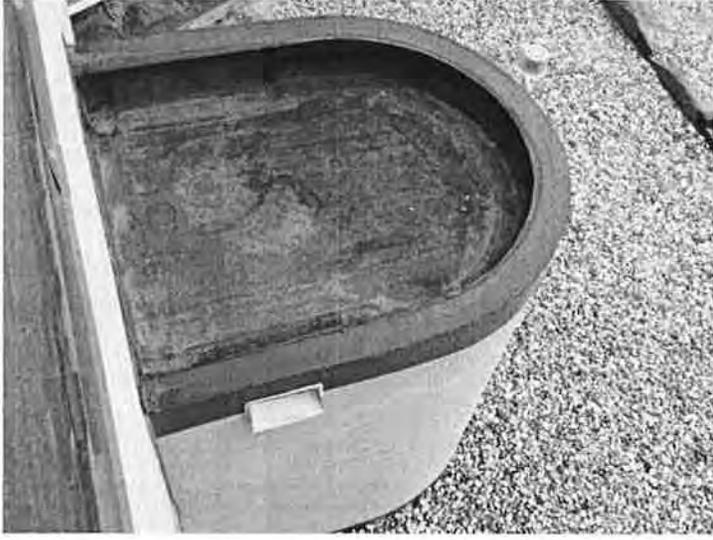
Roof Overview Section 8A

Section 8A is in fair condition overall. The field is well adhered. The perimeter flashing has been repaired and looks great.

Section 8A: No repairs are needed at this time.

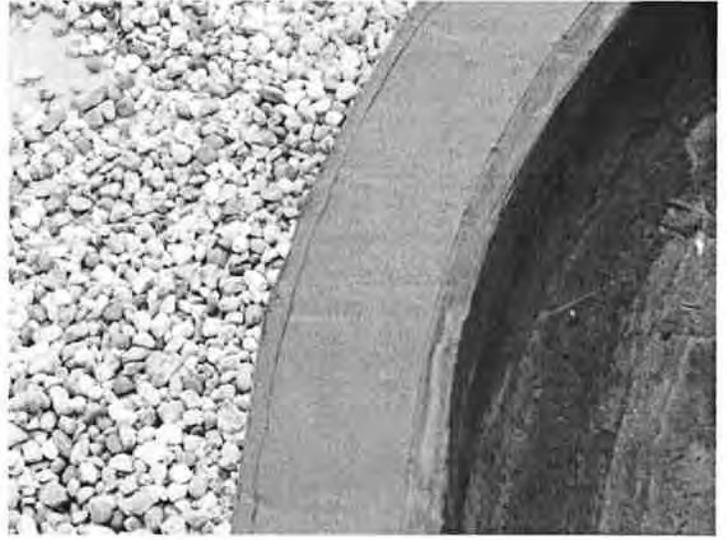
Perimeter Flashing Repaired Nicely

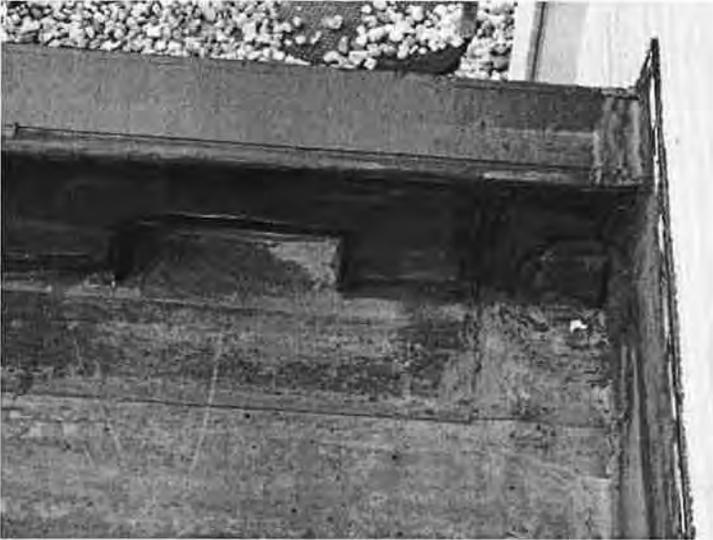
Scupper Details Holding Well

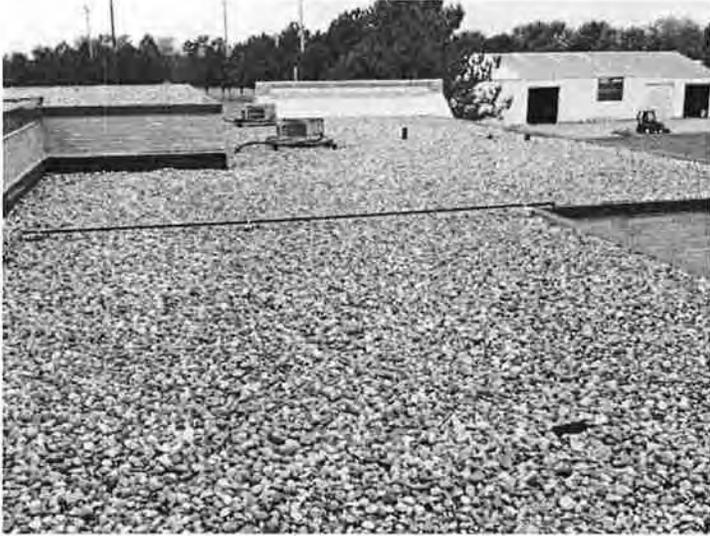
Roof Overview Section 9

Section 9 is in fair condition overall. The roof is evenly ballasted and free of debris. Previous wall re-flash repairs look good, however another run is pulling significantly at the vertical wall.

Section 9: The roof should perform approximately 2-4 years with minor repairs likely.

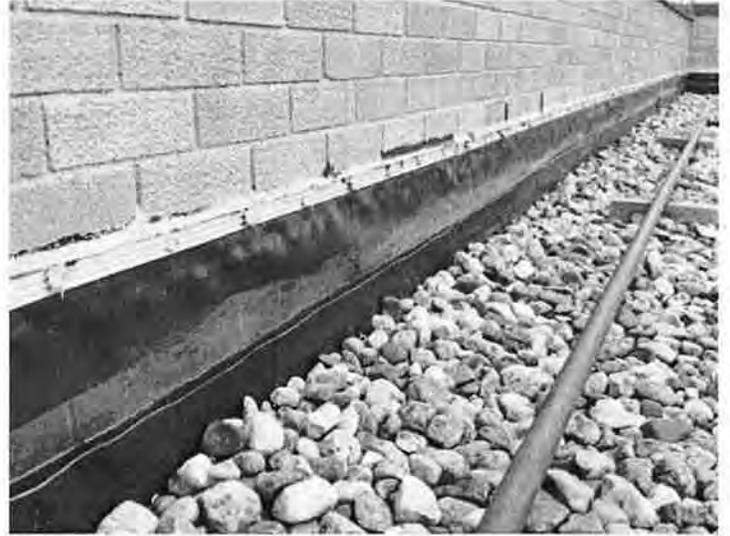
Repaired Wall Flashing Looks Good

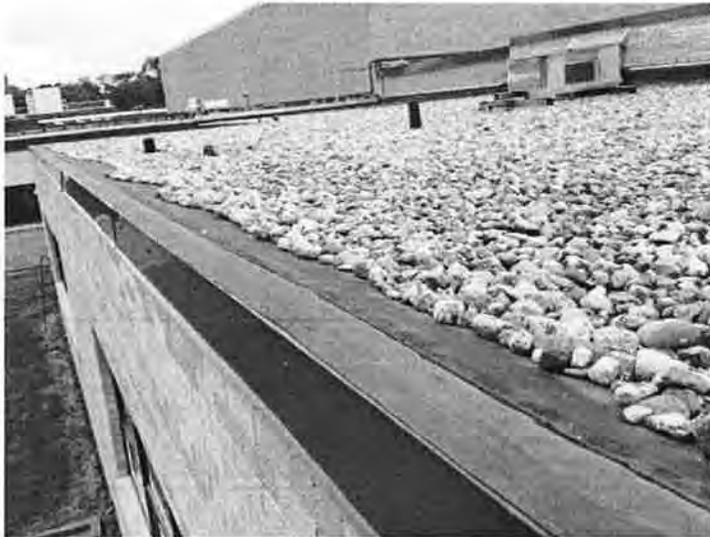
Edges Look Good

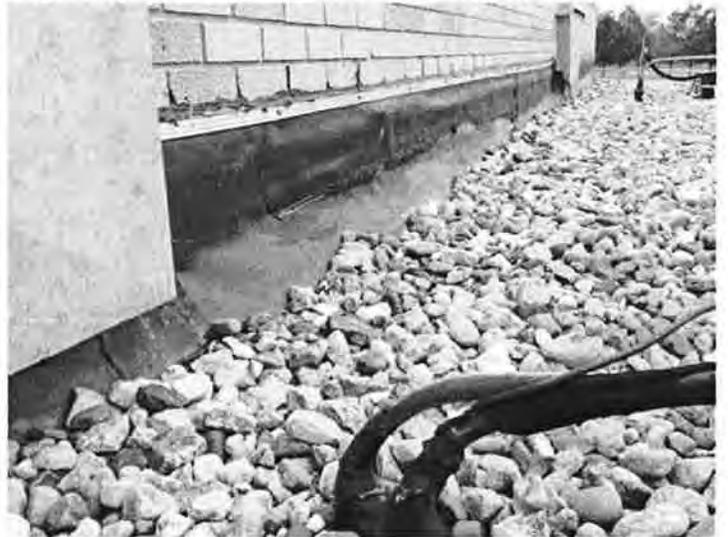
Significant Pulling at Vertical Wall (40')

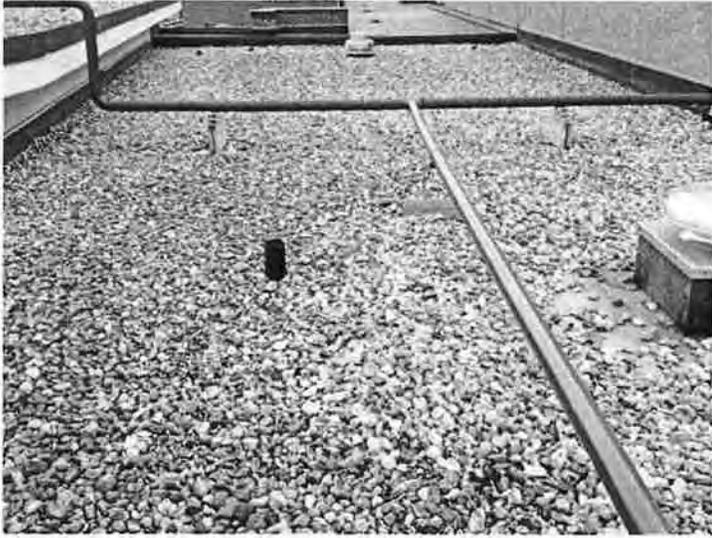
Roof Overview Section 10

Section 10 is in fair condition. Overall the field is evenly ballasted and free of debris and the drain is properly sumped. Past repairs look good and are holding well. New penetration & curb details look good.

Section 10: No additional repairs are needed at this time.

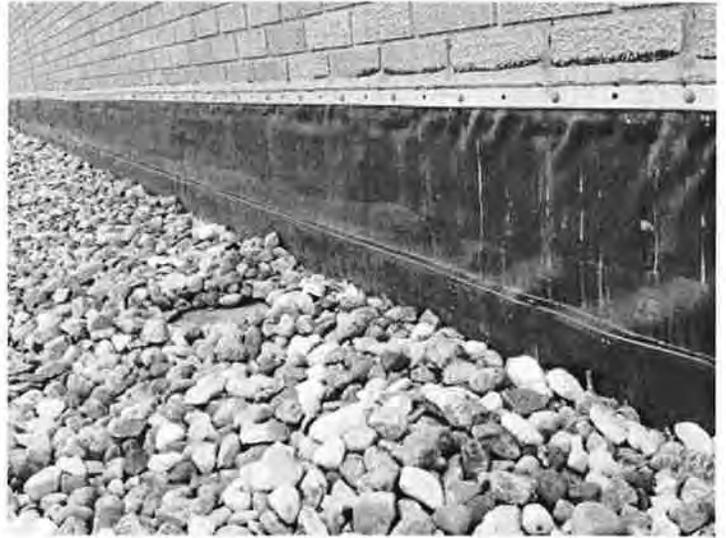
Repaired Wall Flashing Looks Good

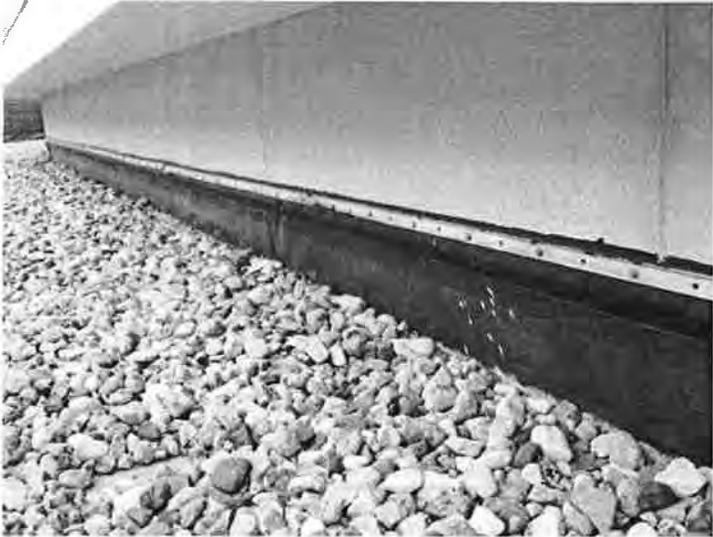
Vertical Wall Flashing Looks Acceptable

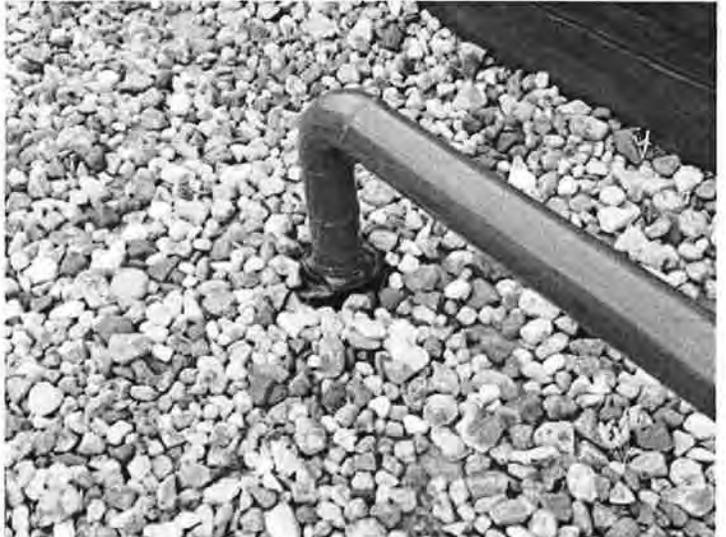
New Penetration Detailed Properly

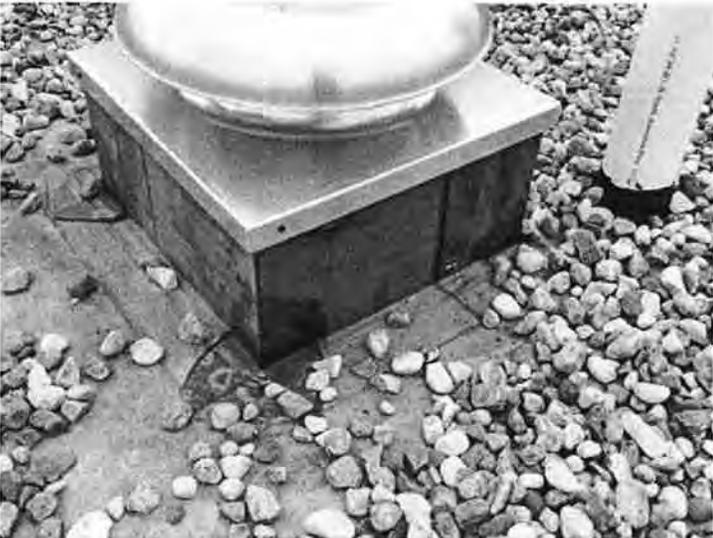
New Curb Detailed Properly

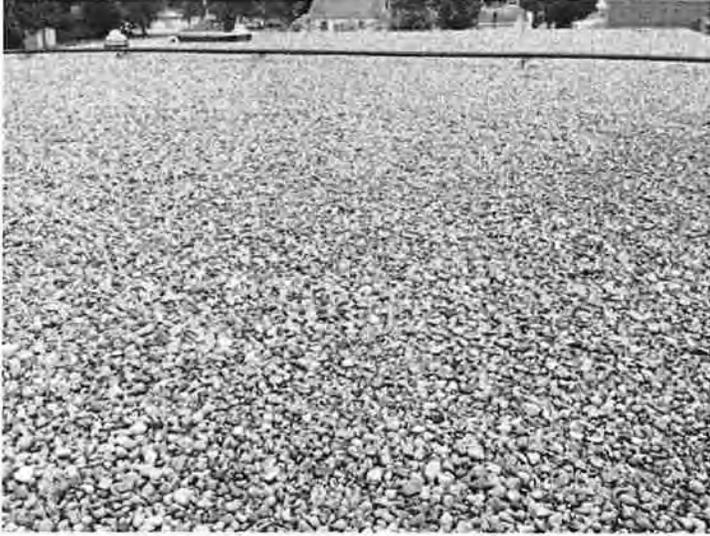
Roof Overview Section 11

Section 11 is in good condition. The field is evenly ballasted and free of debris. The flashings appear to be well adhered and performing properly. New wall details where an addition has been added look good. An awkward transition area near a roof drain looks poor but at the same time appears watertight.

Section 11: No additional repairs are needed at this time

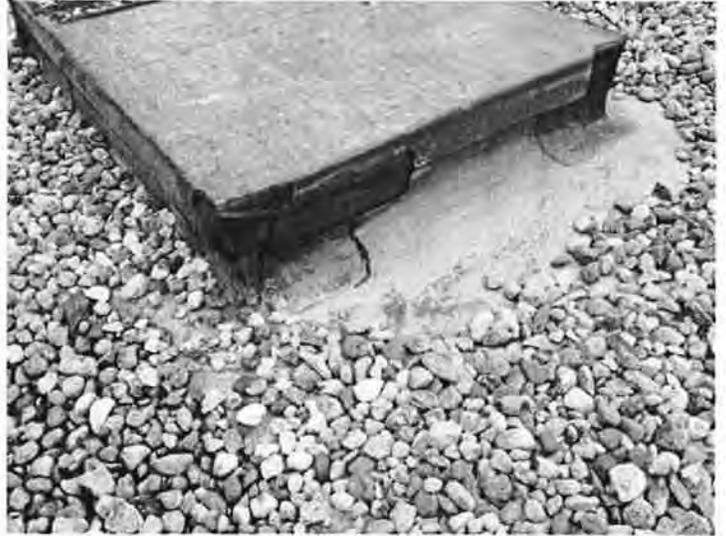
Curb Details Look Good

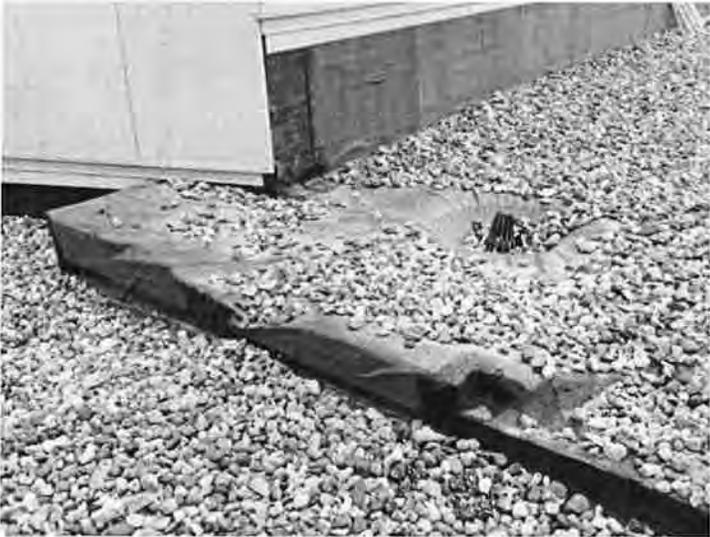
Transition Area Looks Poorly Done

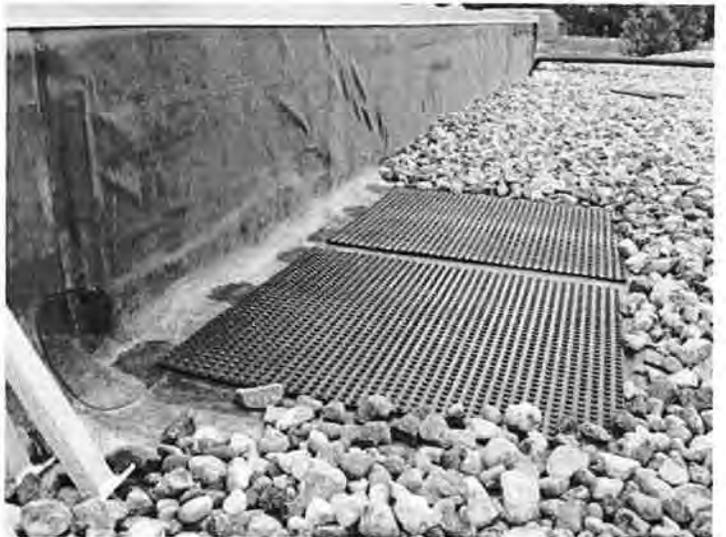
Vertical Wall Details Look Acceptable

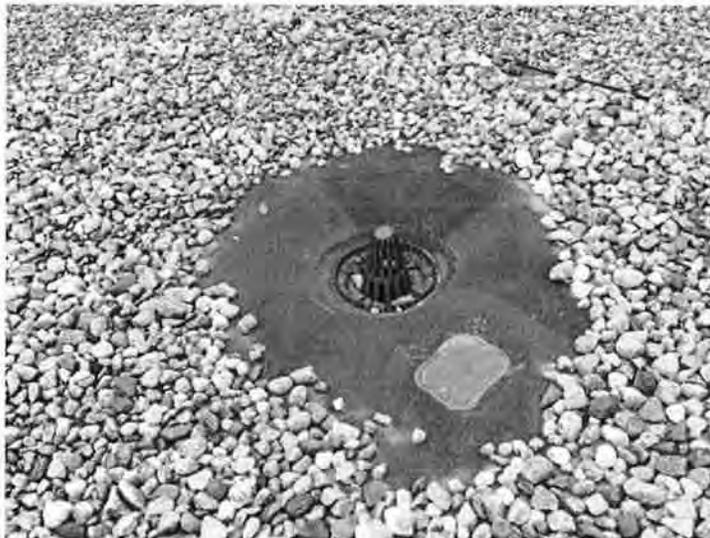
Properly Sumped Drain

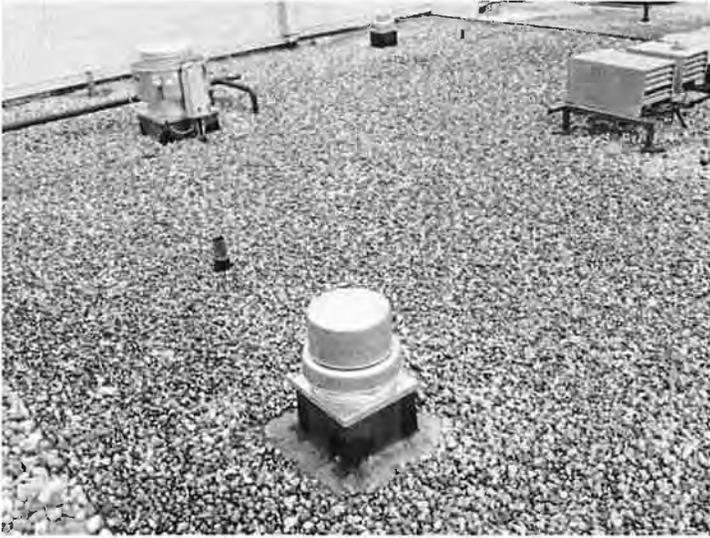
Roof Overview Section 12

Section 12 is in fair condition. The field is evenly ballasted and free of debris. Curbs have been recently repaired at the corner details and look good. Field seams are beginning to experience lifting. There is a frozen HVAC at a pitch pan.

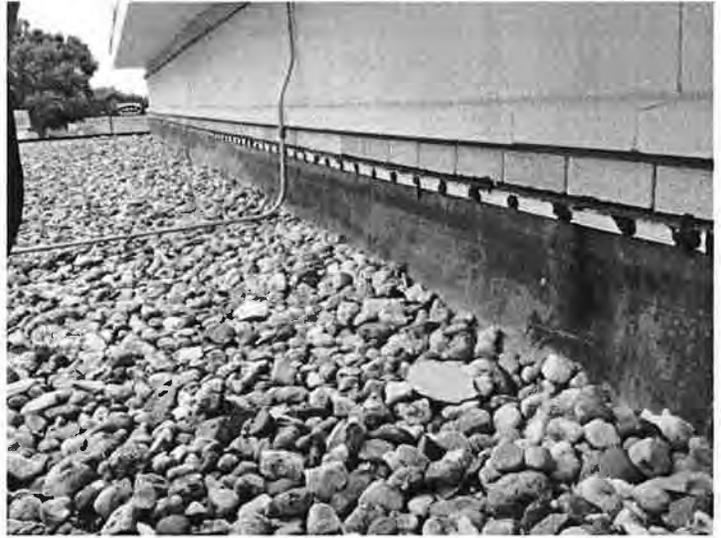
Moderately Pulled Wall Flashing

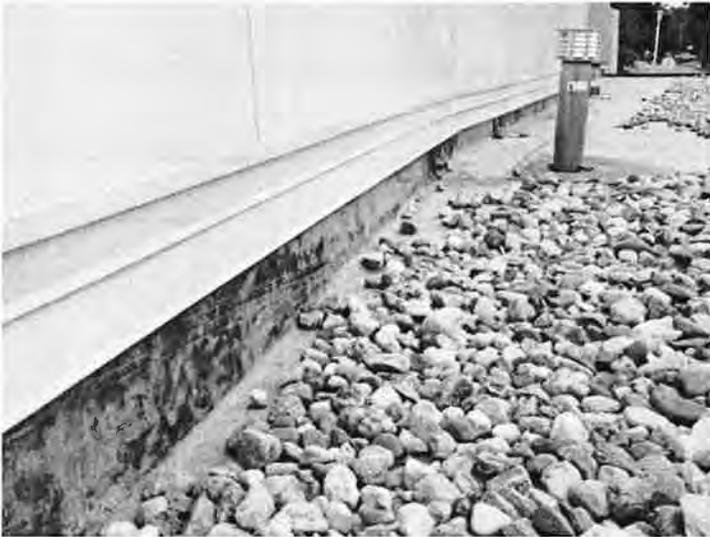
New Vertical Wall Details Look Good

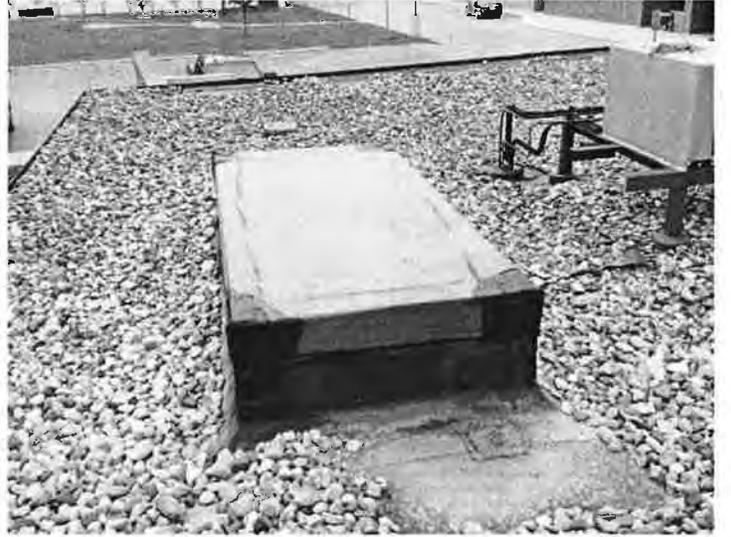
Newer Curb Corner Details Look Good

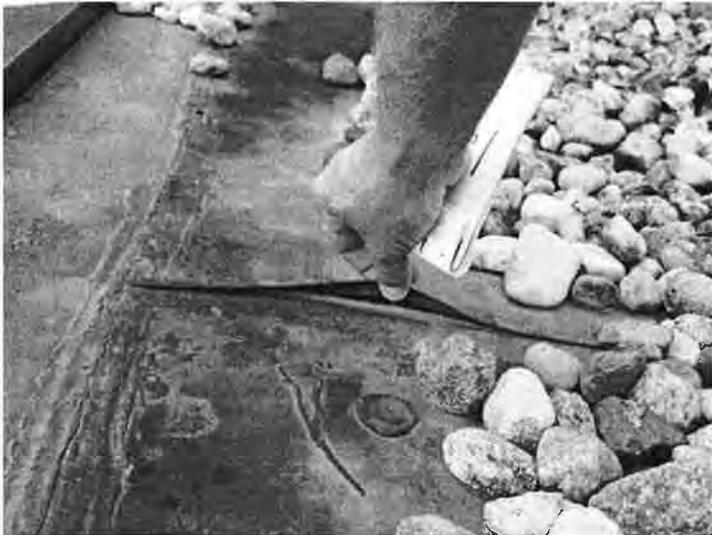
Field Seam With Minor Lifting

Section 12: The frozen HVAC line should be repaired by an HVAC contractor. The lifting field seams should be monitored.

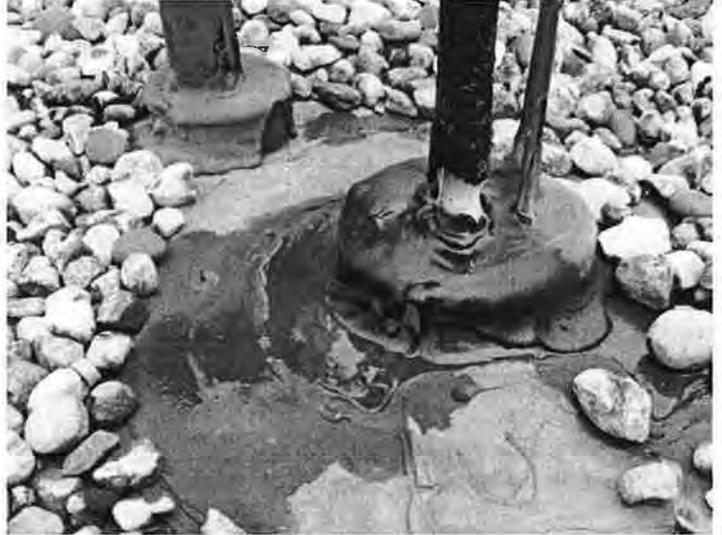
Frozen HVAC Line at Pitch Pan

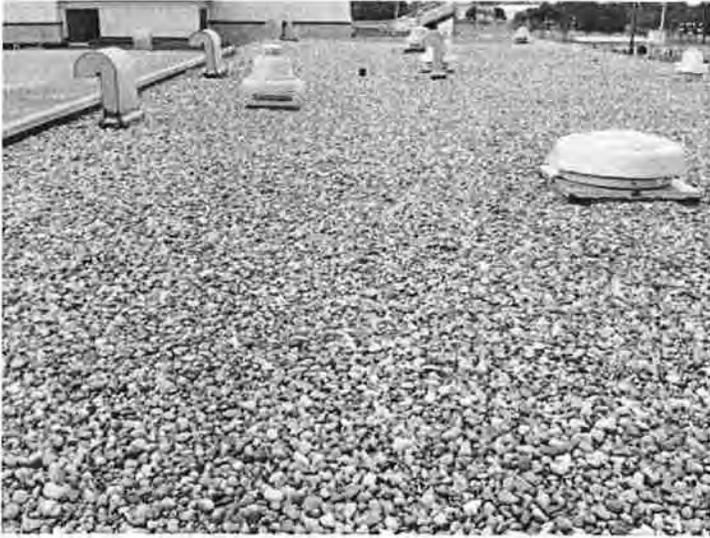
Roof Overview Section 13

Section 13 is in fair condition. The field is evenly ballasted and free of debris. Curb repairs look good, however the perimeter edges continue to pull.

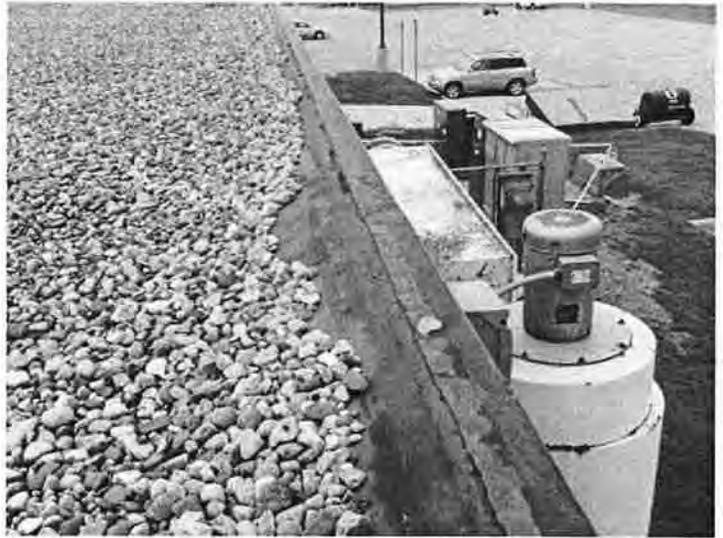
Pulling at Perimeter

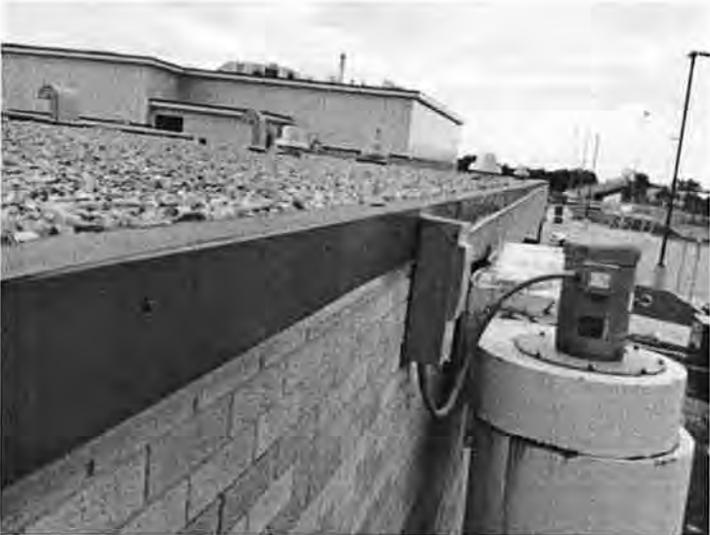
Edge Metal Secured Well to Wall

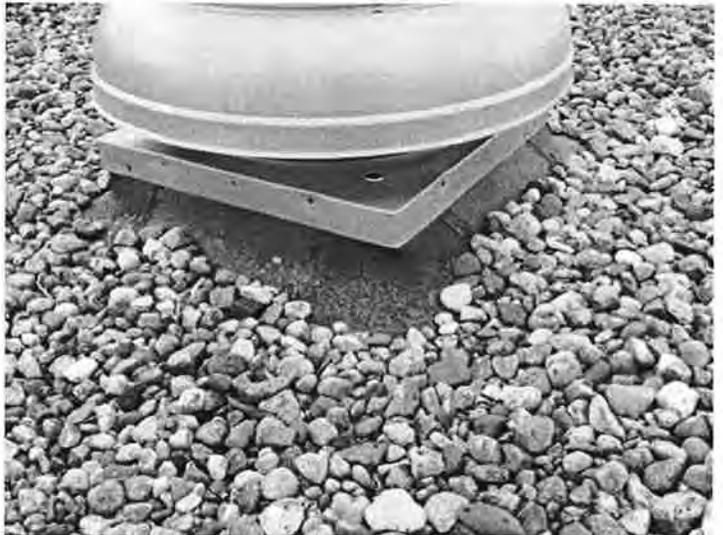
Curb Nicely Repaired in The Past

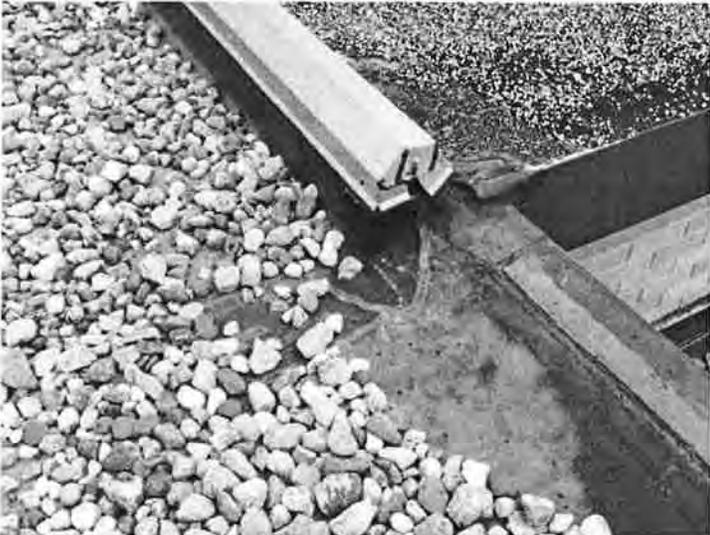
Nice Flashing Repair to Division Wall

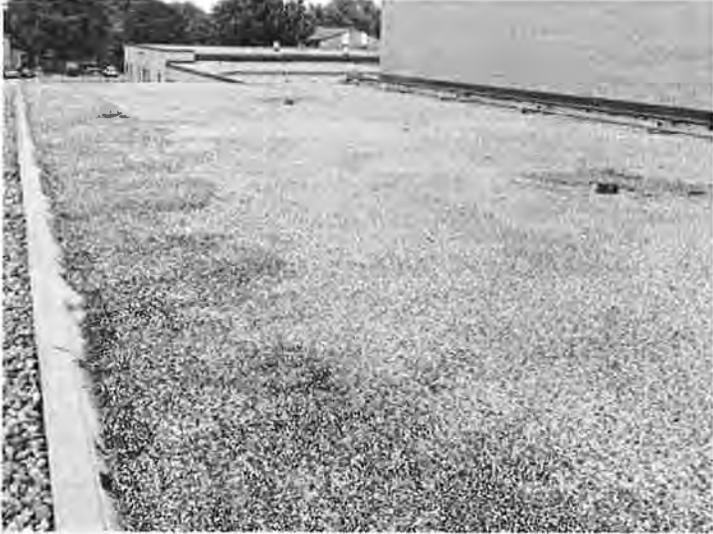
Roof Overview Section 14

Section 14 is in fair condition. The field appears to be holding-up well, however the wall flashings appear to be moderately deteriorating and showing signs of aging. Several areas along the south are exposing felts which happens as the roof ages.

Section 14: No repairs are needed at this time, however the moderately deteriorating wall flashings should be monitored as well as areas of exposed felts along the south.

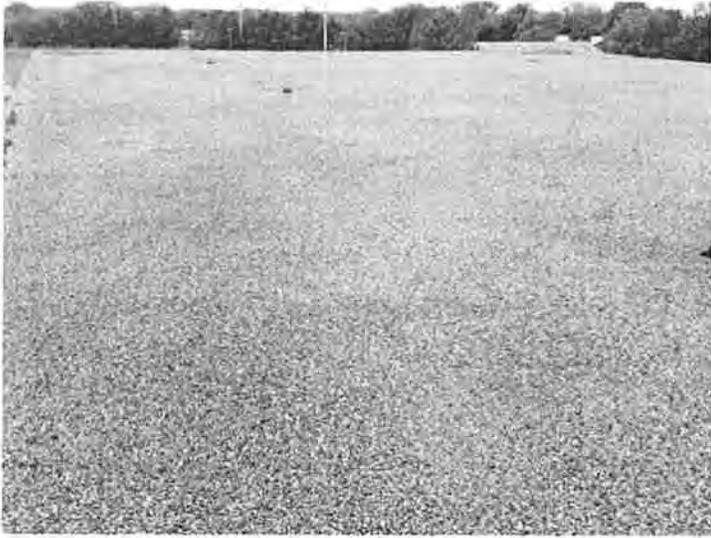
Roof Overview Section 15

Section 15 is in poor condition. The field appears to be holding-up, but is showing signs of its age. There are areas where the field felts and edge flashings are showing noticeable signs of deterioration. Most of the perimeter edge is failing now including an area that was previously repaired with roof cement. It has deteriorated and opened up in a couple small areas.

Section 15: The entire perimeter edge flashings should be repaired by applying roof cement and cotton membrane. If possible, a reroof could be considered soon to avoid repairing for what would be a short time (1-3 years).

Section 15: The roof should perform approximately 1-3 years with repairs.

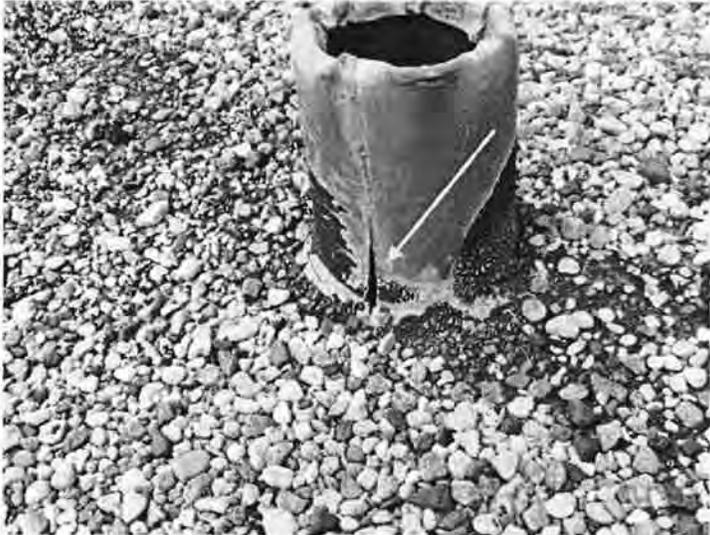
Open Flashing at Soil Stack

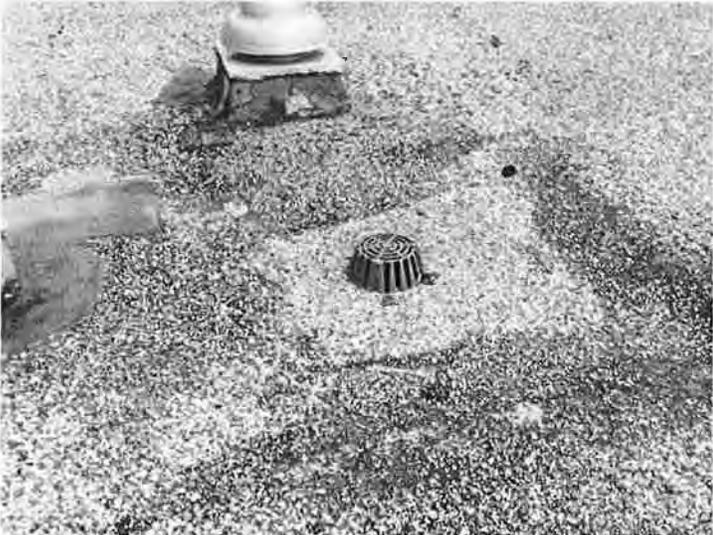
Exposed Felts at Drain & Penetration Details

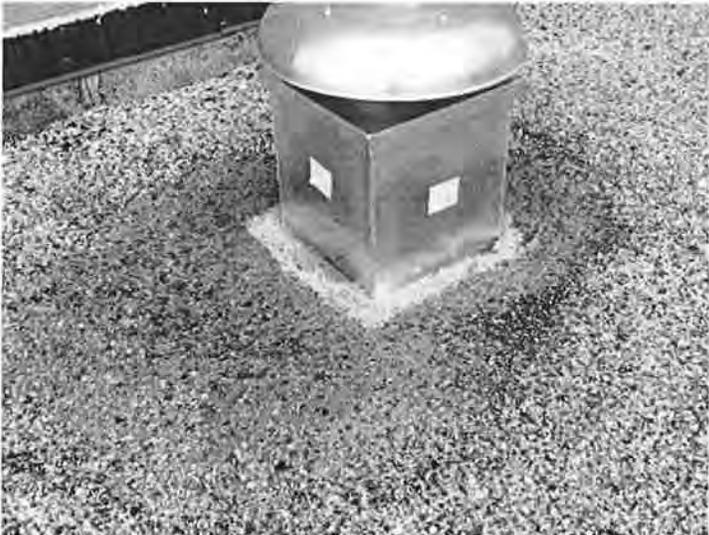
Newer Curb Detail Suspect

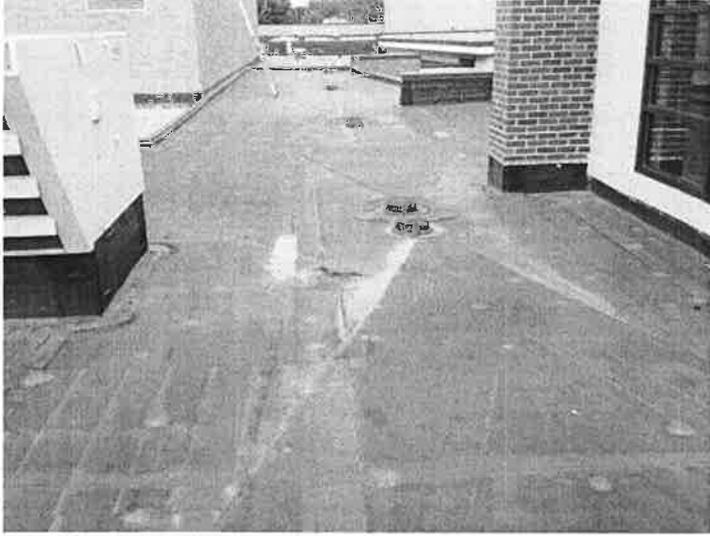
Roof Overview Section 17

Section 17 is in excellent condition. The field is well adhered. The field seams and all flashings appear to be performing properly.

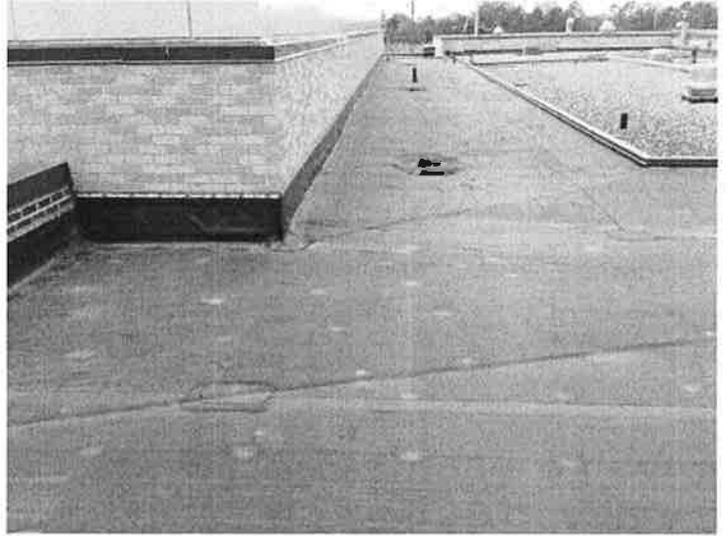
Roof Overview Section 17

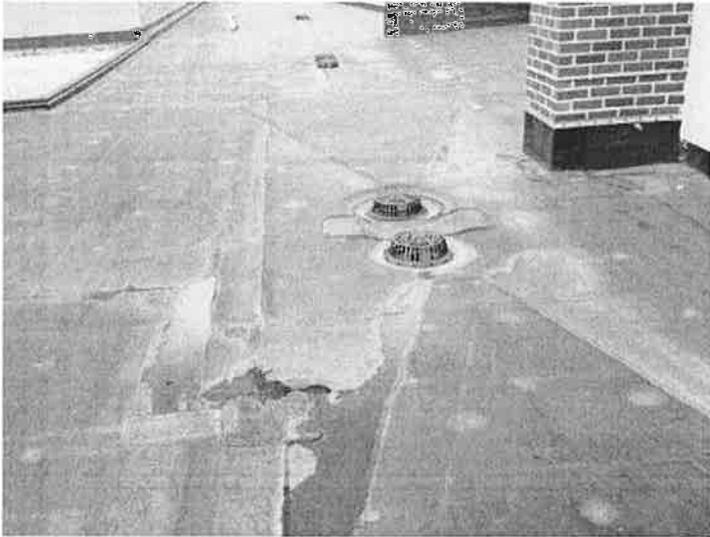
Crickets Installed (Look Great)

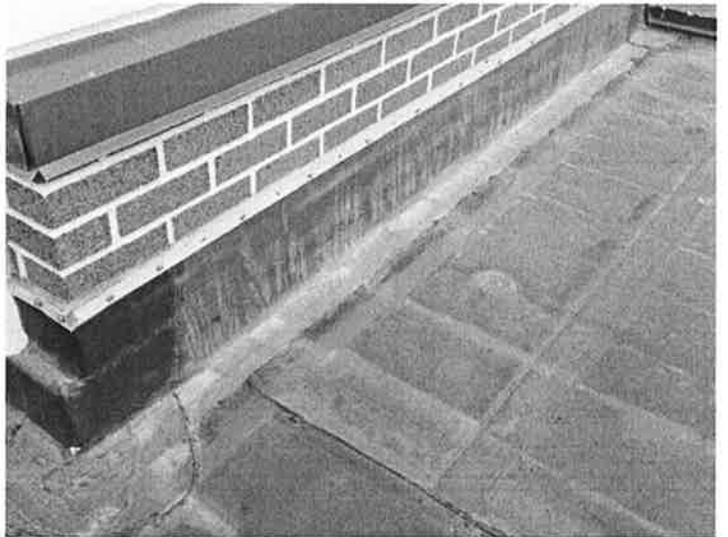
Vertical Wall Termination Nicely Done

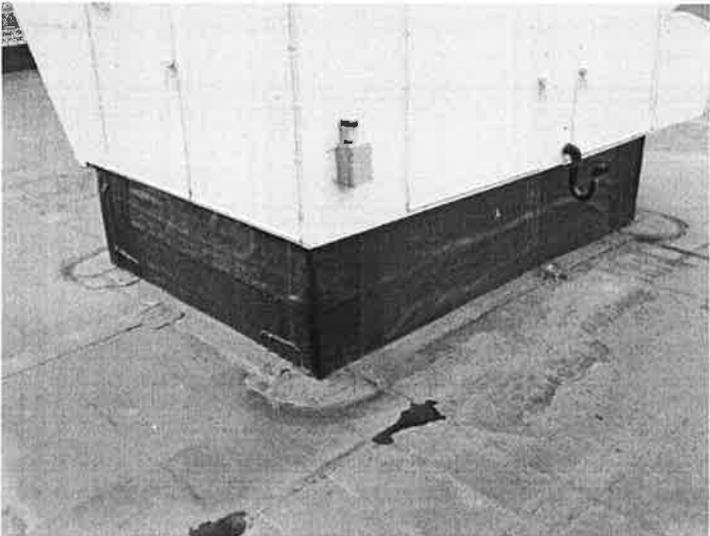
Curb Details Nicely Done

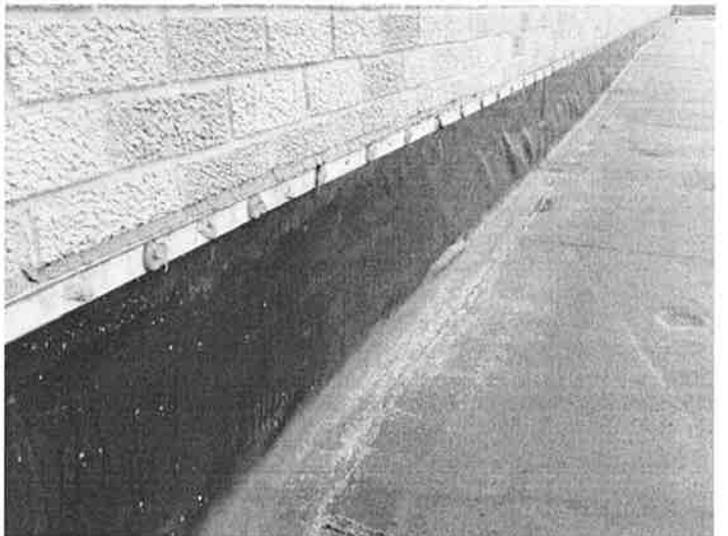
Vertical Wall Looks Great

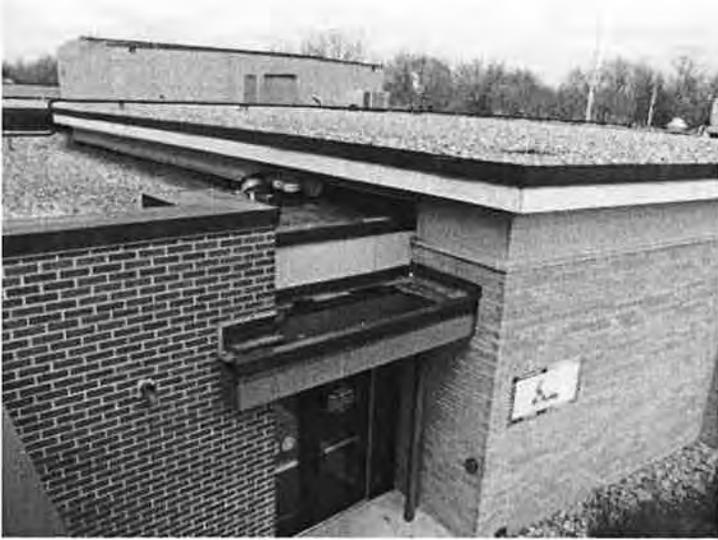
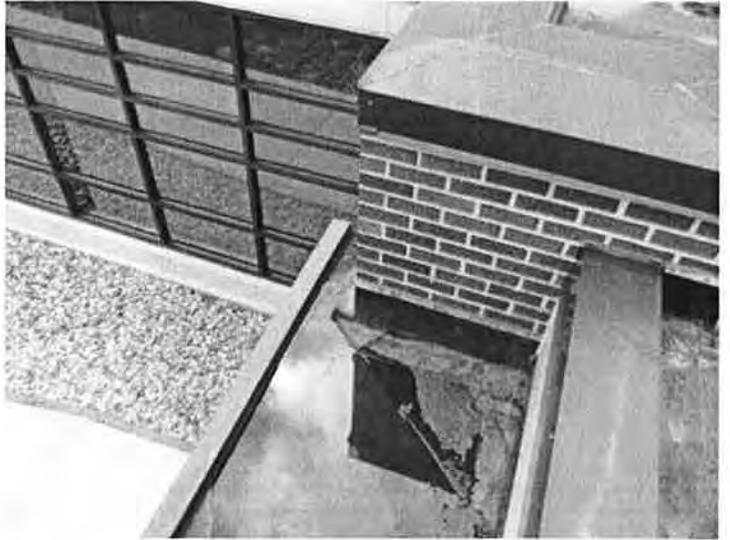
Roof Overview Section 17A

Section 17A is in excellent condition. The field is well adhered. The field seams and all flashings appear to be performing properly. This section has significant ponding.
