ASSESSMENT REPORT

OKOBOJI CSD

OKOBOJI, IOWA

FEH DESIGN

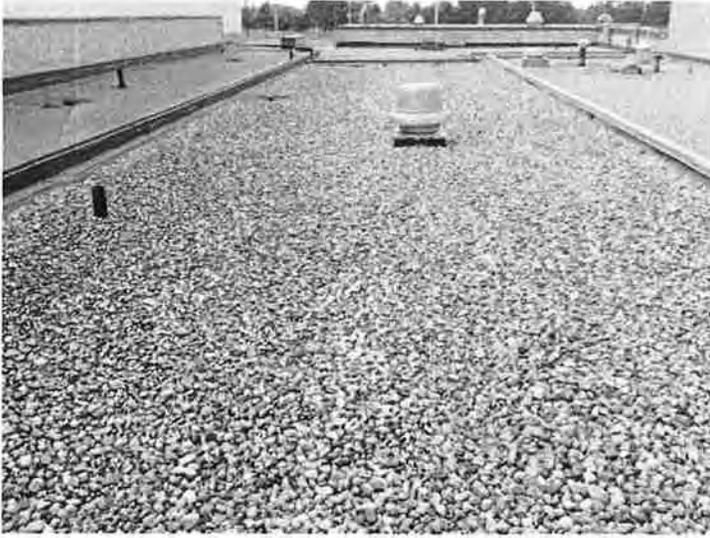
Roof Overview Section 18

Section 18 is in fair condition. The field is evenly ballasted and free of debris. The flashings are well adhered and performing properly. There is a corner where no termination bar was installed, leaving this detail unfinished. A run of moderate pulling exists at the parapet wall.

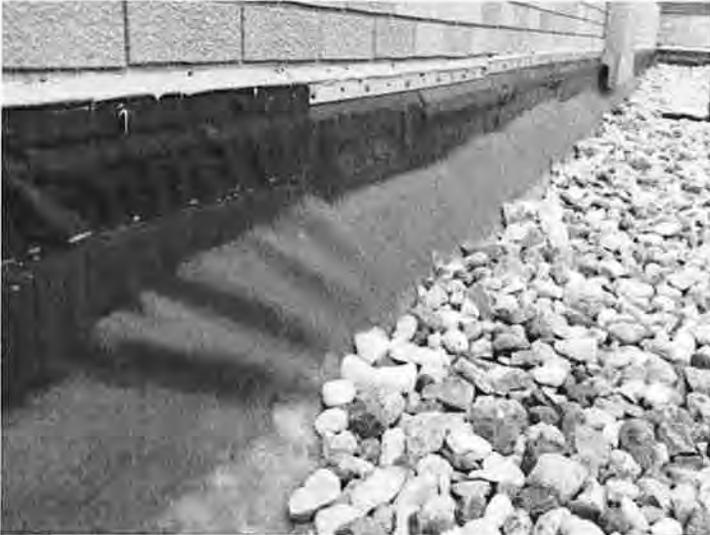
Moderately Pulling Wall Flashing

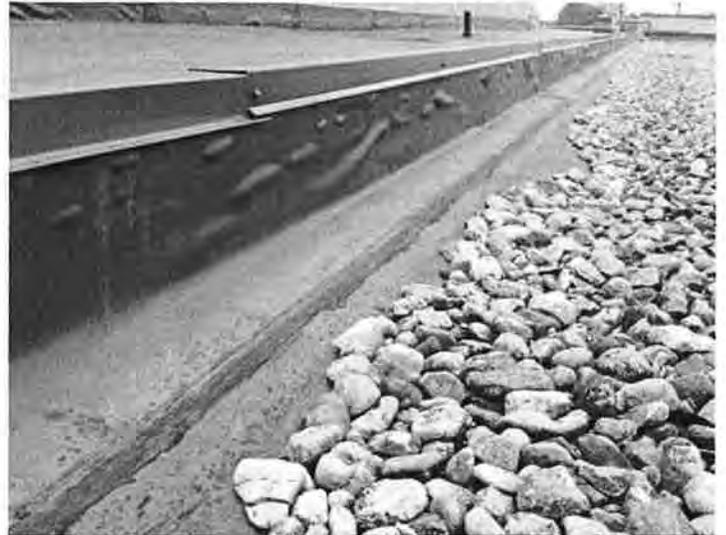
Past Wall Repair Looks Good

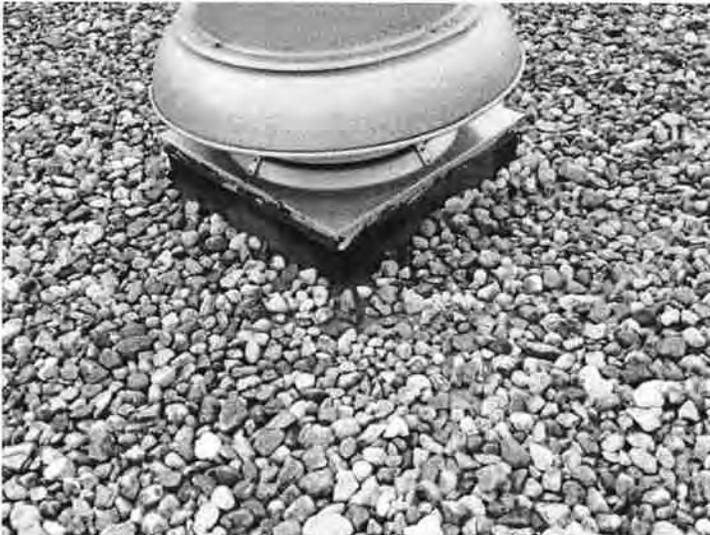
Moderate Pulling at Curb Details

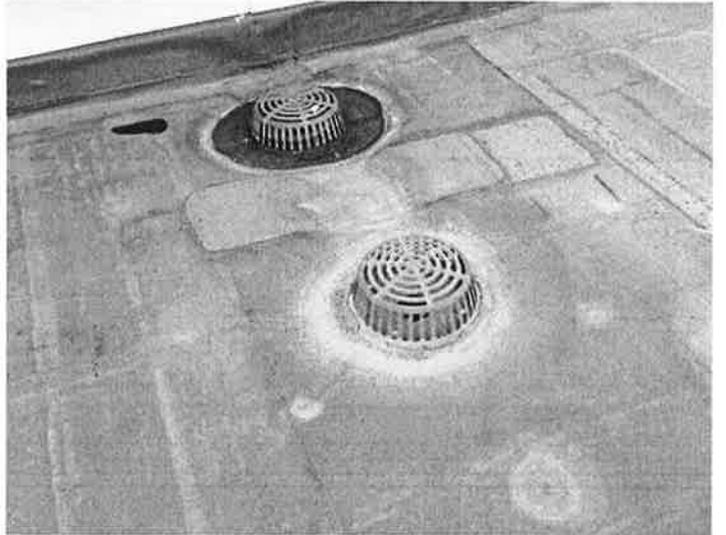
Properly Sumped Drains

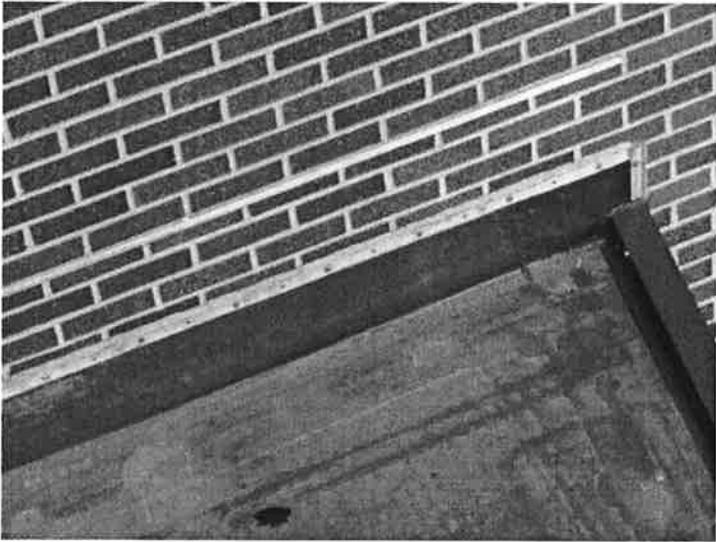
Vertical Wall Termination Looks Good

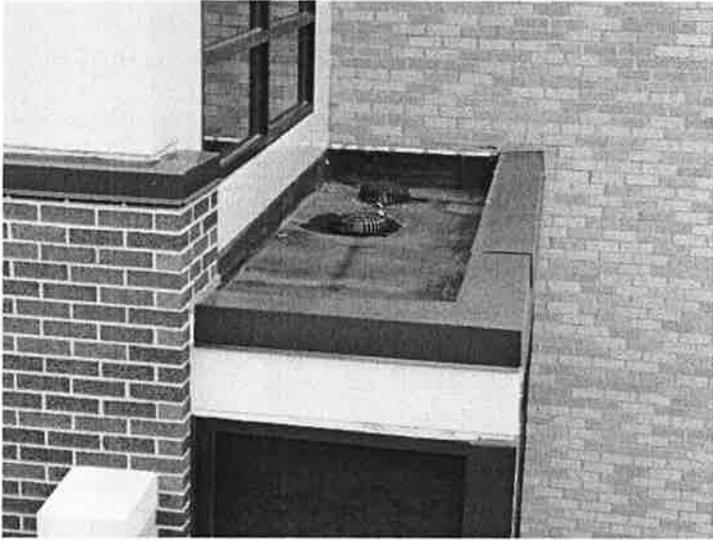
Roof Overview Section 20

Section 20 is in excellent condition. The field is well adhered. The field seams and all flashings appear to be performing properly. This section does appear to pond a large amount of water, most likely due to the scupper being installed too high for water to drain properly. The fasteners in the cap metal were installed through the top of the cap. This is not a recommended installation, because it leaves the areas around the fasteners susceptible to possible leaks.

Section 20: No repairs are needed at this time, however the ponding and the top fastened cap metal should be monitored annually.

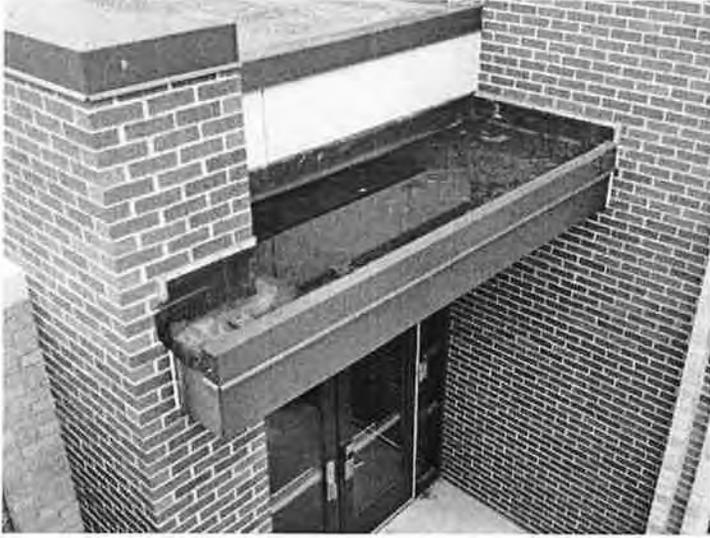
Roof Overview Section 21

Section 21 is in excellent condition. The field is well adhered. The field seams and all flashings appear to be performing properly.

Section 21: No repairs are needed at this time.

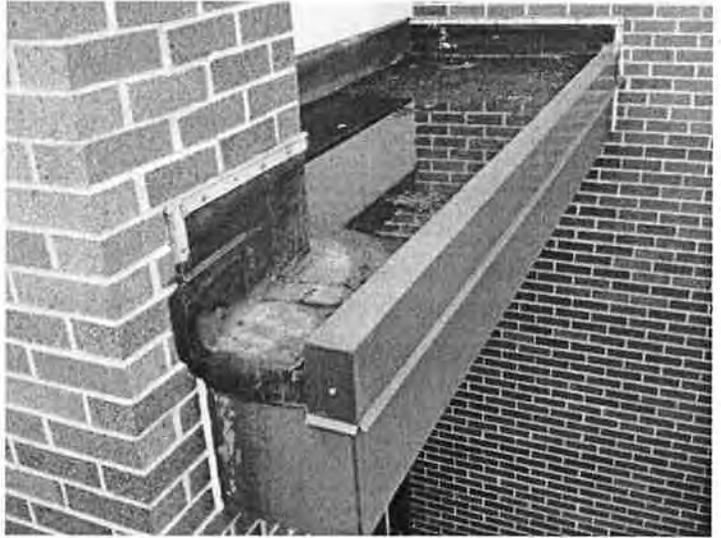
Cap Metal Looks Good

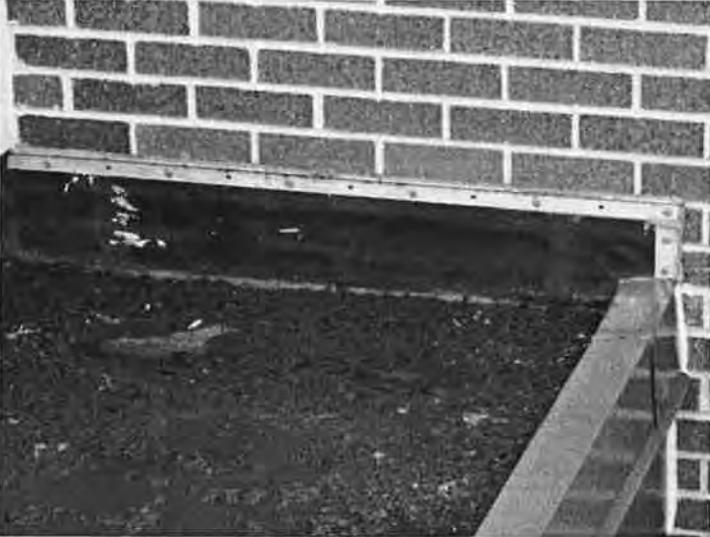
Termination Bar Detailed Properly

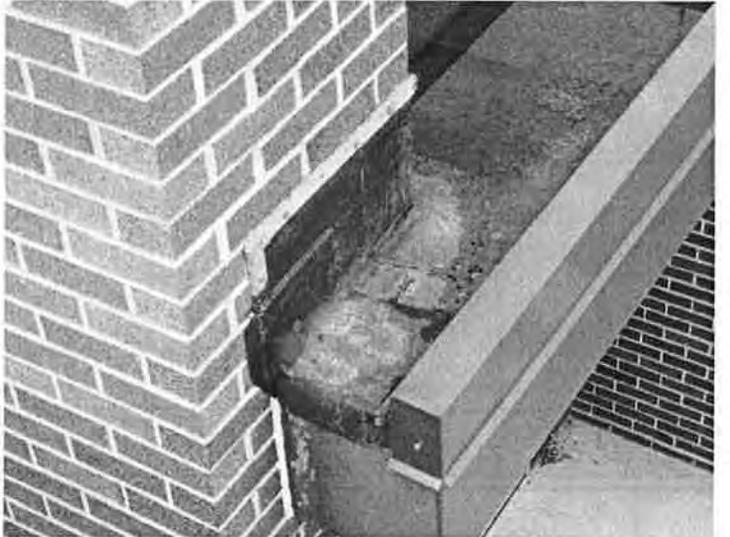
Drain Point Detailed Well

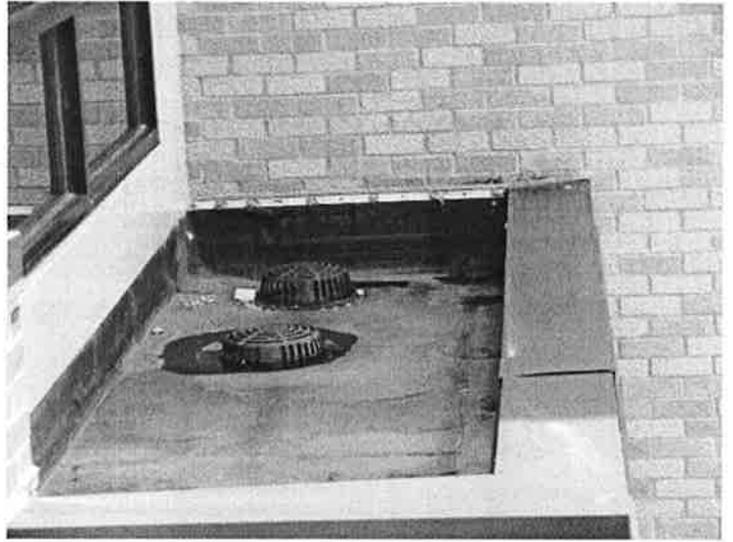
Roof Overview Section 21A

Section 21A is in excellent condition. The field is well adhered. The field seams and all flashings appear to be performing properly.

Section 21A: No repairs are needed at this time.

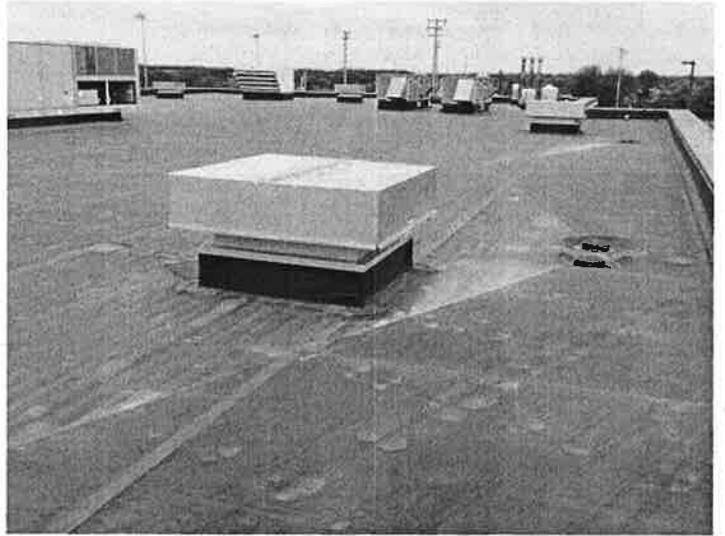
Roof Overview Section 22

Section 22 is in excellent condition. The field is well adhered. The field seams and all flashings appear to be performing properly.

Section 22: No repairs are needed at this time.

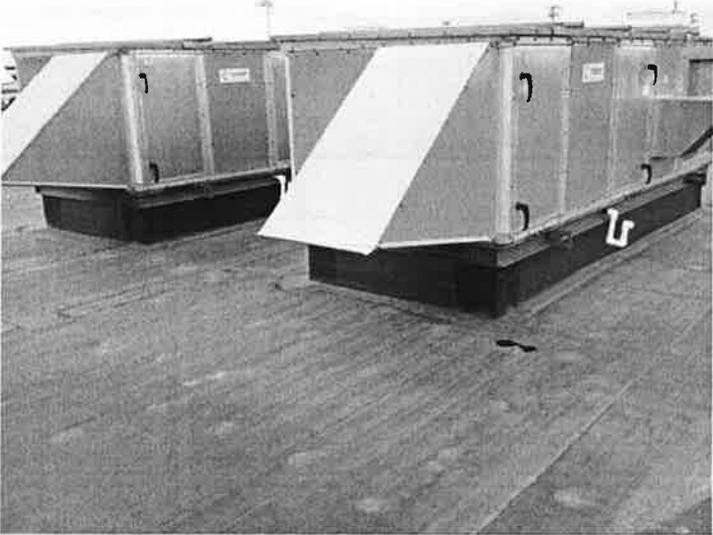
Properly Flashed Curb

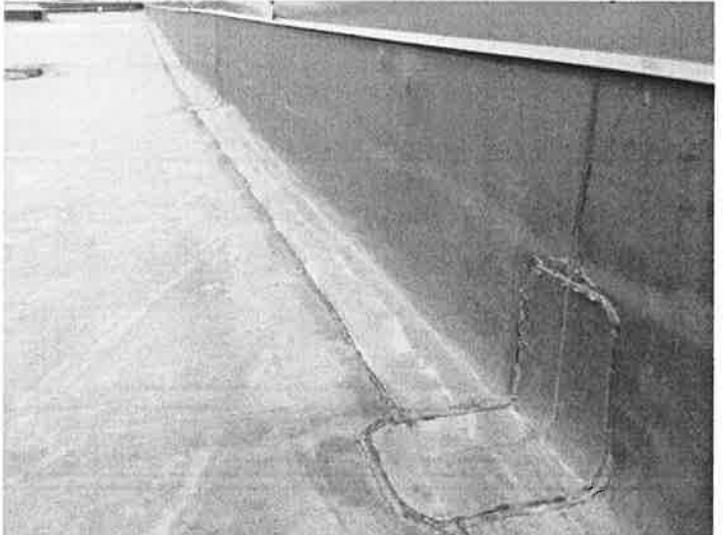
Membrane Nicely Adhered at Walls

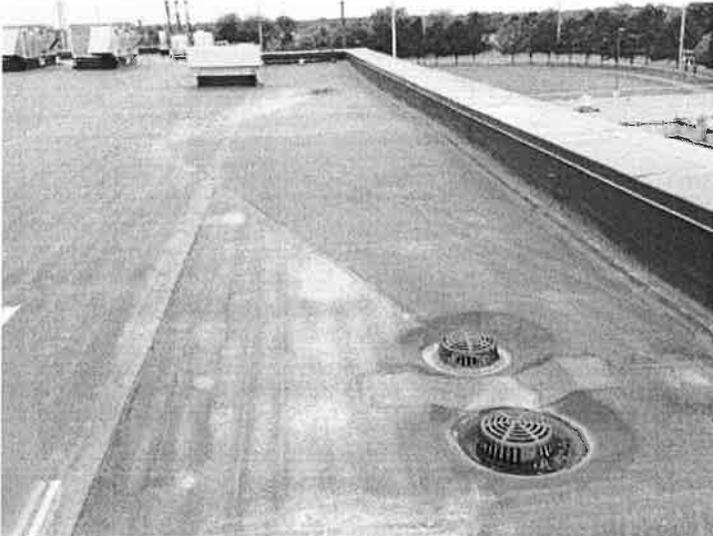
Crickets Nicely Designed at Drains

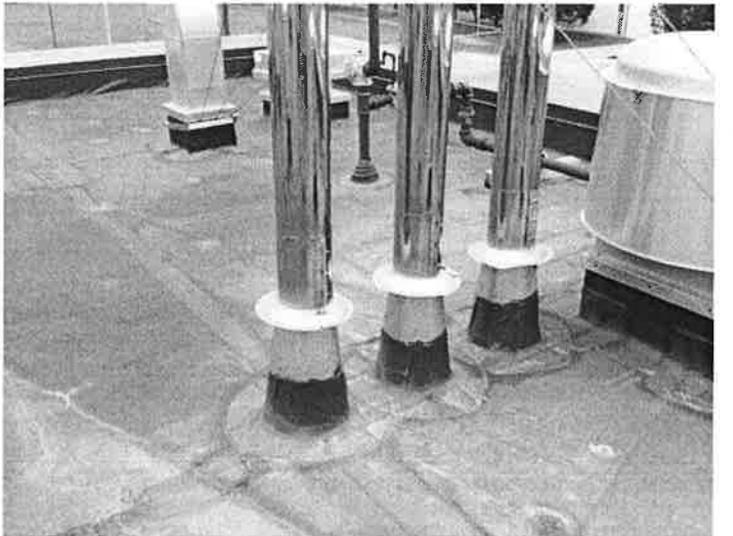
Penetration Details Look Good

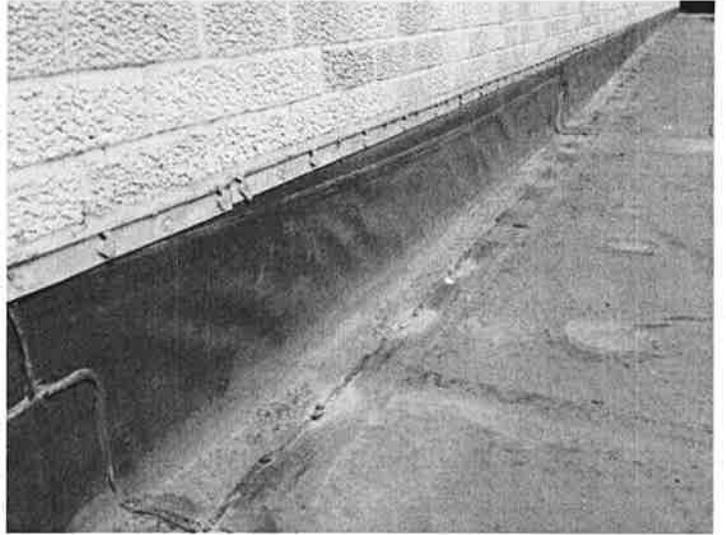
Vertical Wall Nicely Done

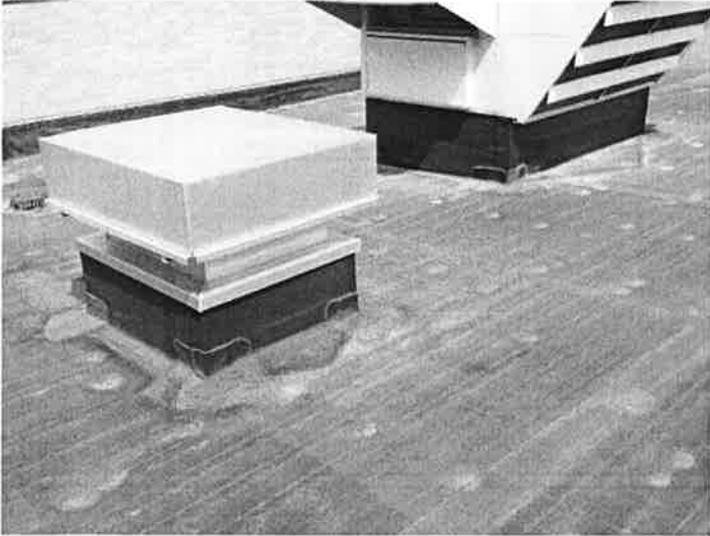
Properly Flashed Curbs

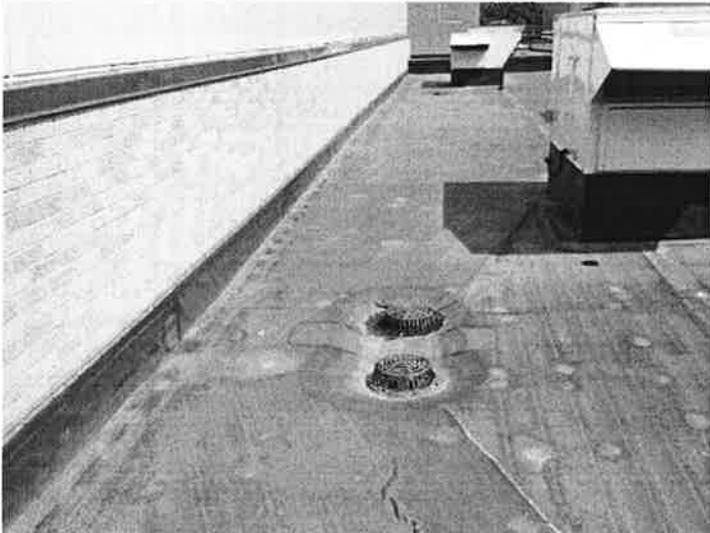
Crickets Nicely Designed at Drains

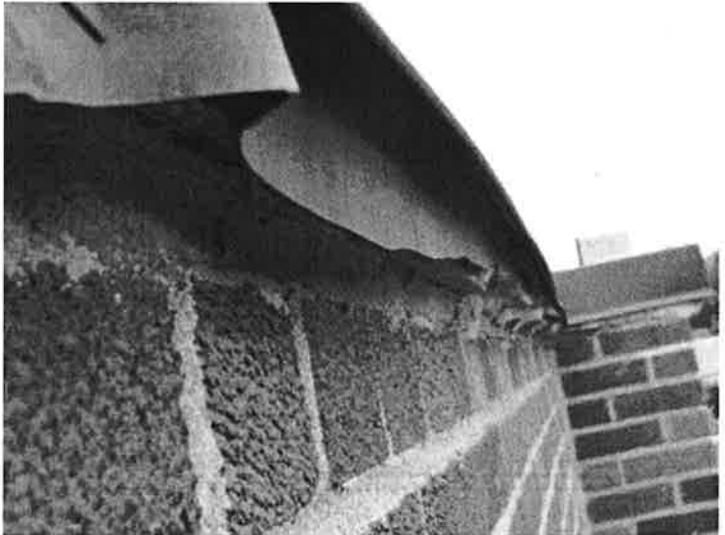
Poor Workmanship on Parapet Wall

Section 3: No repairs are needed at this time. The HVAC unit should be placed back on the slip sheet. A slip sheet could be placed under the conduit stands. The installing contractor could be contacted about the workmanship at the parapet wall to improve the detail work as well as secure the fasteners at the cap metal.

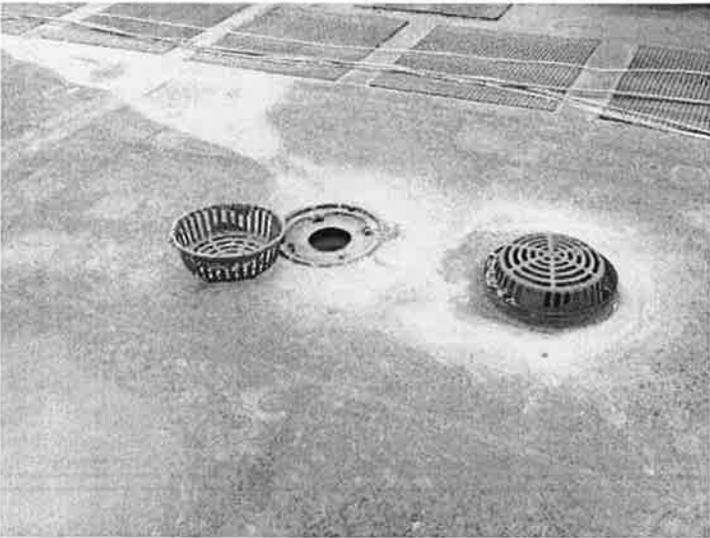
Drain Bonnet Removed (Maintenance Was Cleaning)

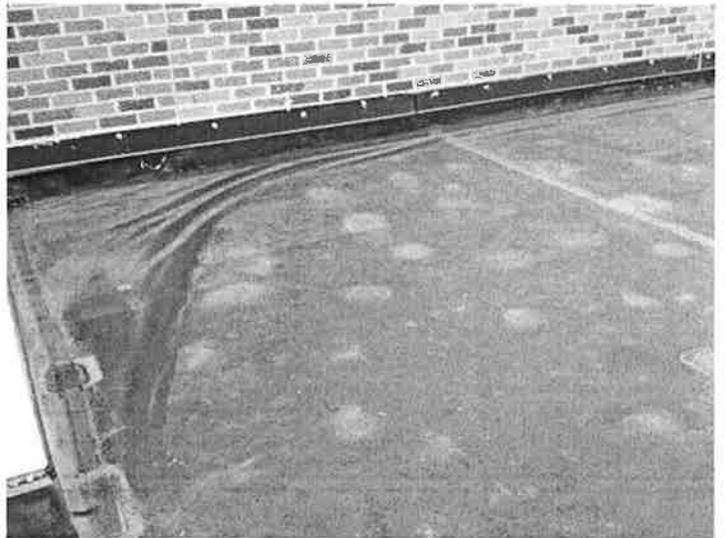
Wrinkles In Field (Perhaps A Wind Event)

Section 4 is in good condition. Overall, the field is well adhered. The field seams and flashings appear to be holding-up well. There is an area with a minor amount of delaminating field membrane perhaps from a wind event. This section has had recent repairs done to stoop leaks. A majority of the leaks have been stopped, but not 100%. There is still a leak in the vicinity of several penetrations. Lastly, this section ponds a minor amount of water.

Section 4: The roof should be further investigated for the reported leak.

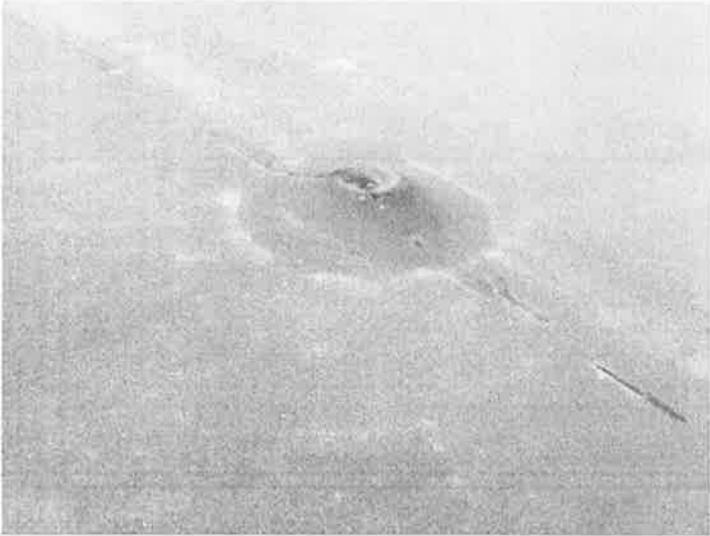
Suspect Tented Fastener

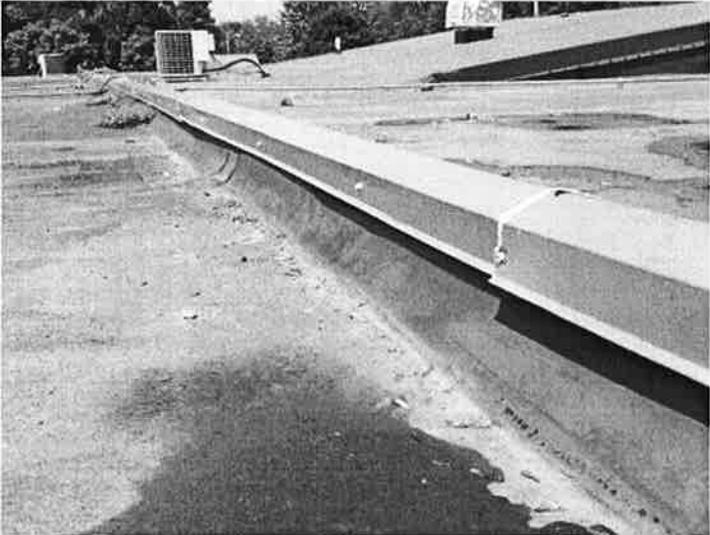
Minor Pulling Along Division Wall

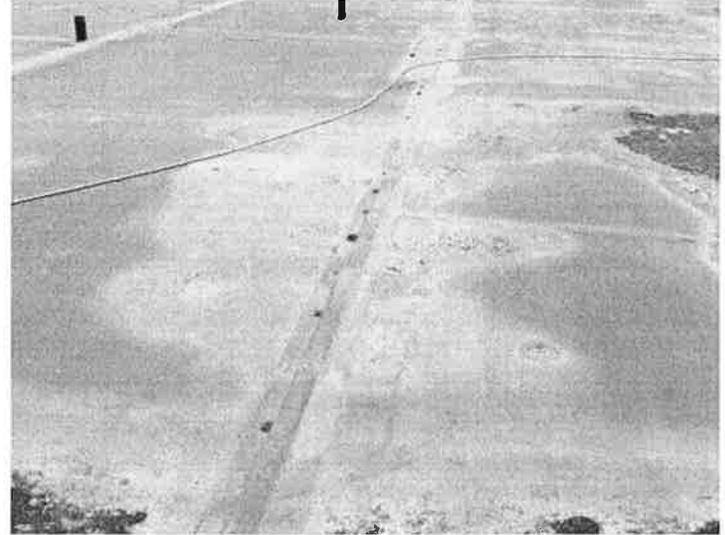
5" Quick Seam Holding But Gas Pockets Common

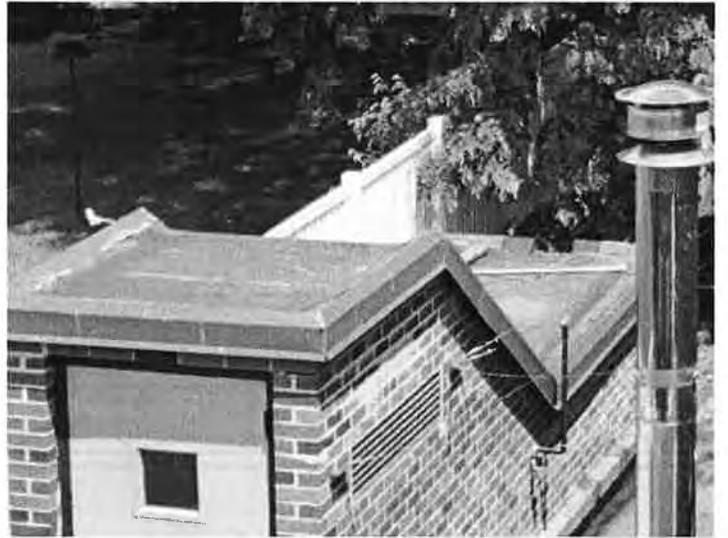
Perimeter Metal Flashings Look Acceptable

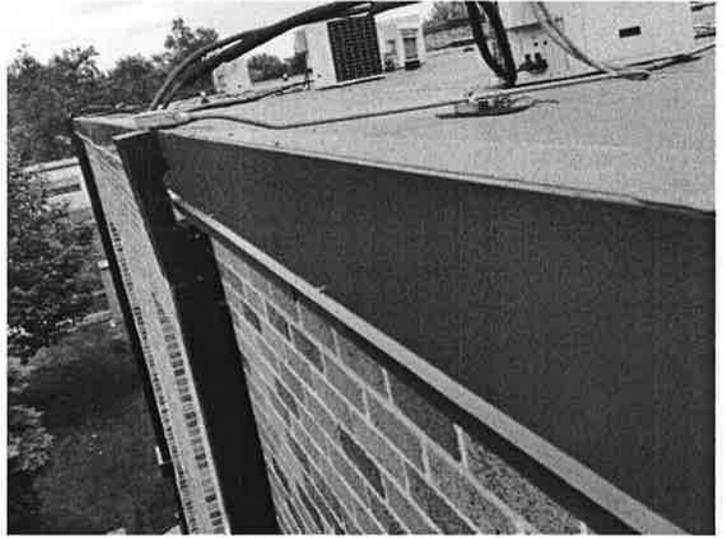
Edge Metal & Flashing Looks Good

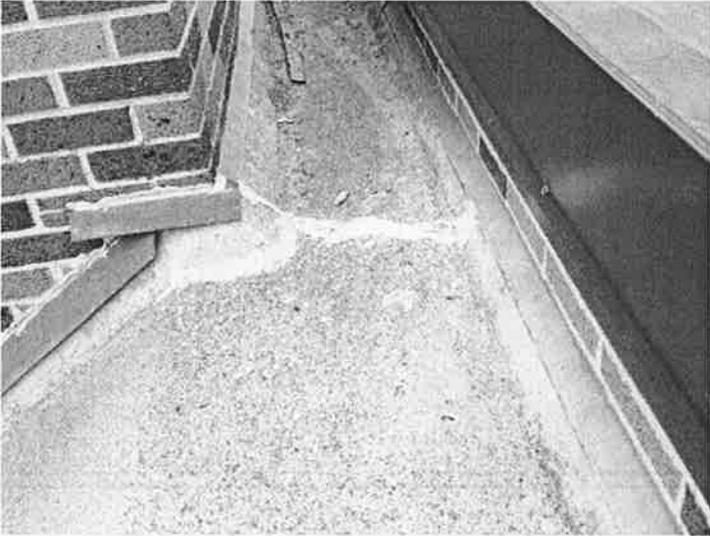
Sealant Over Crack Holding Well

Section 7 is in good condition. The concrete had one minor crack in it that was caulked.

Section 7: No repairs are needed at this time.

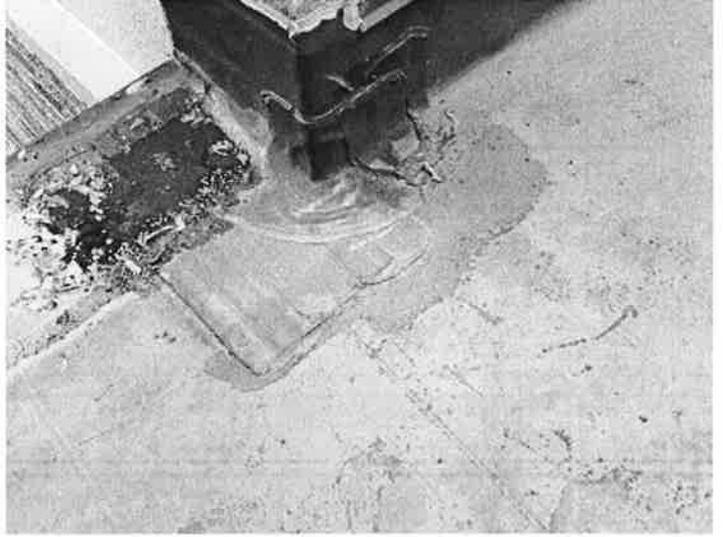
Recent Corner Flashing Repair Looks Good

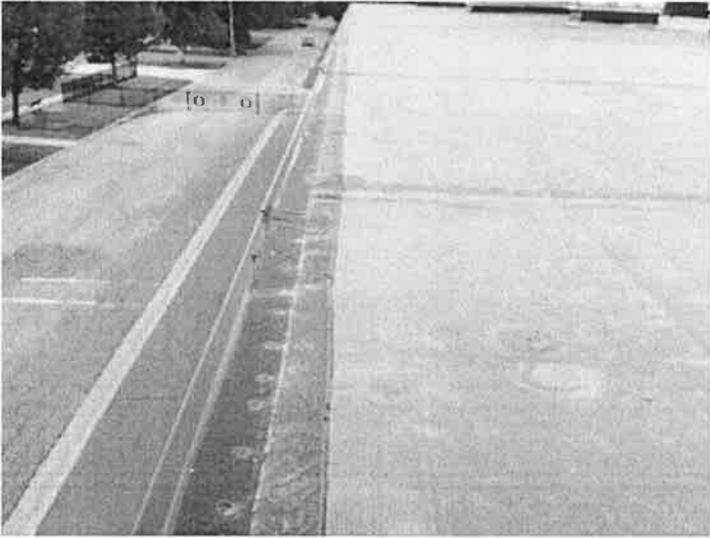
Properly Flashed Roof Edge

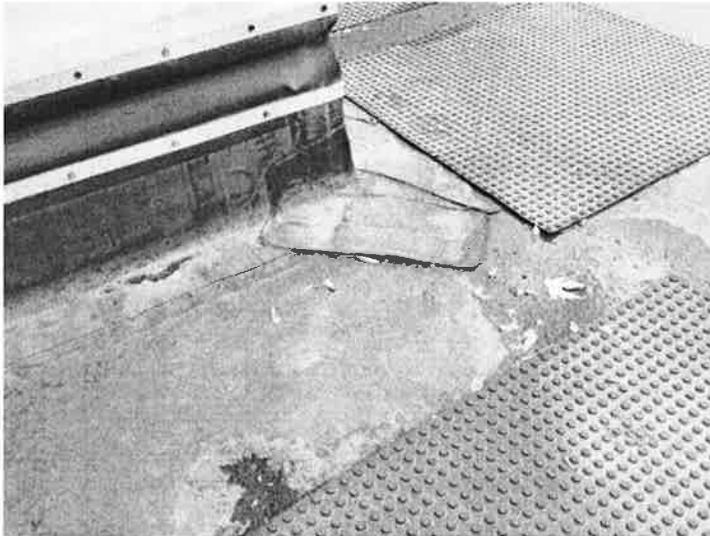
Lifting Curb Corner Flashing

Section 12 is in excellent condition. The field is well adhered but ponds some water. The field seams and flashings appear to be properly installed and performing well. Due to the wick height, there is an unavoidable low termination detail on the upper portion of this section. The sealant above the termination bar is cracked in places. The joint where the roof meets the EIFS is failing. There is a lifted curb corner flashing near an area that ponds water.

Section 12: The roof should perform approximately 10+ years.

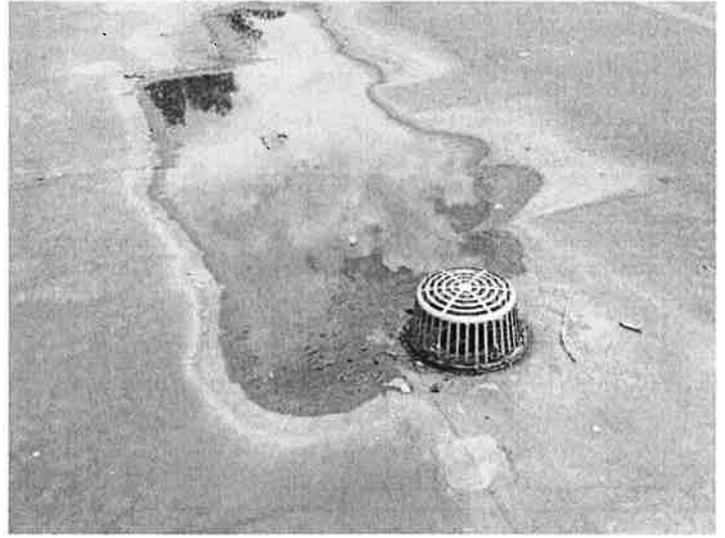
Minor Ponding at Drain

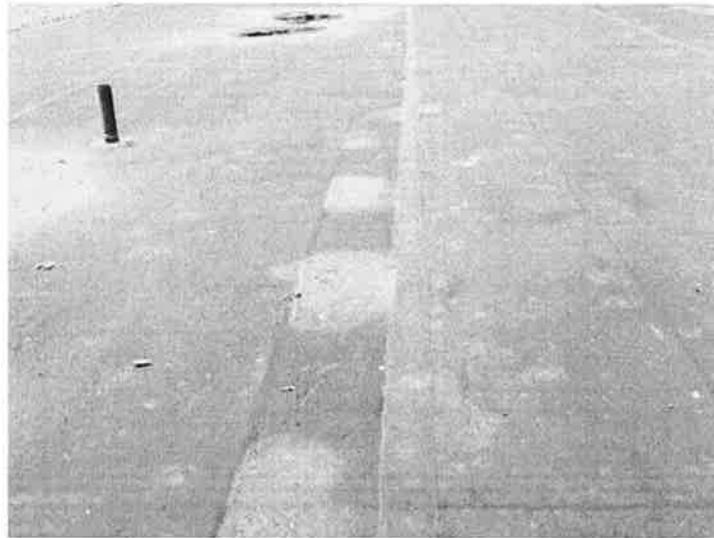
Field Seams Adhered Well

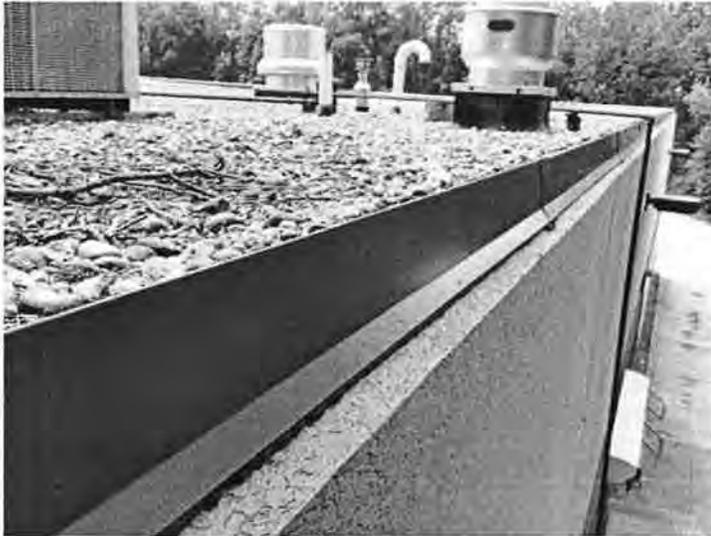
Edge Metal Looks Good

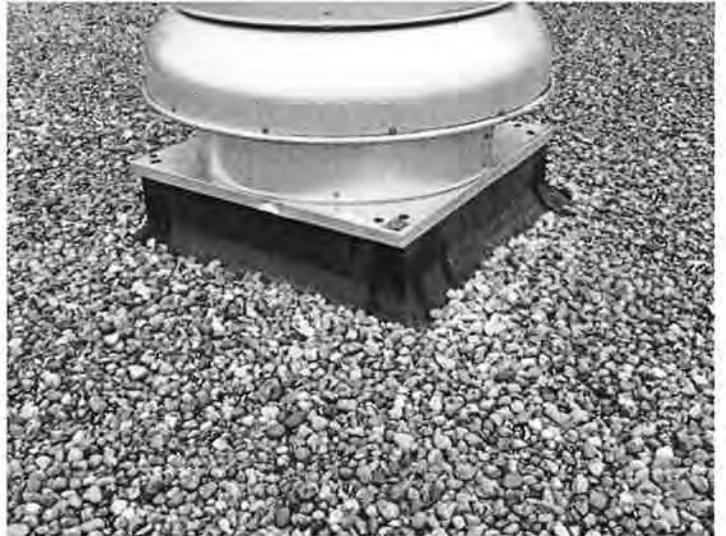
Curb Flashing Starting to Open

Section 2 is in good condition for its age, fair overall. The field is evenly ballasted and free of debris. Overall the flashings are well adhered and performing properly. There are minor runs of pulling and curb corners are starting to come loose. This is typical as the roof ages.

Section 2: The roof should perform approximately 4-6 years with repairs likely during that time.

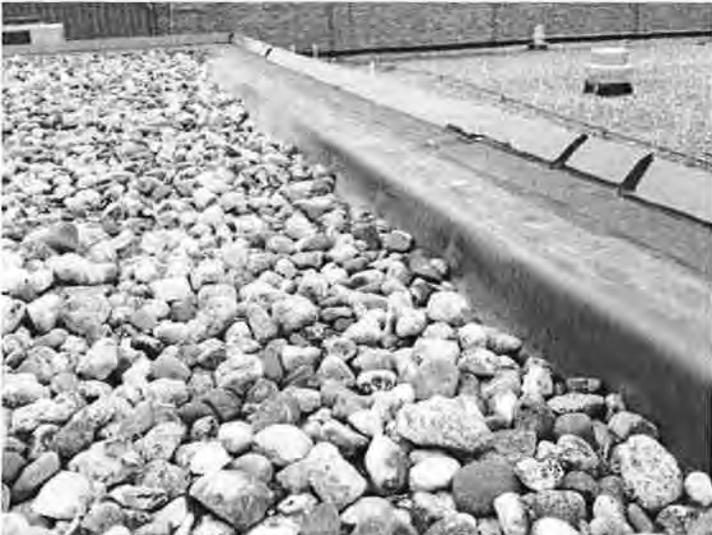
Pulling At Wall

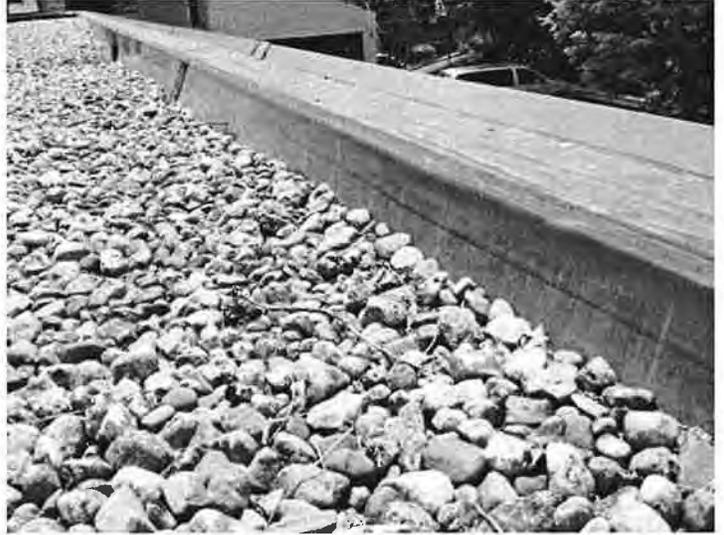
Moderate Pulling at West Wall

Section 3 is in fair condition for its age. The field is evenly ballasted and free of debris. There is moderate pulling in runs, and pulling around curbs. A few curb corners are lifting and a couple corner details are open. This is typical as the roof ages.

Section 3: The open curb corners should be properly patched. Suspect/lifted corners could also be patched. Because the roof doesn't have many years of life left it is not cost effective to repair the pulling along the walls and therefore should continue to be monitored.

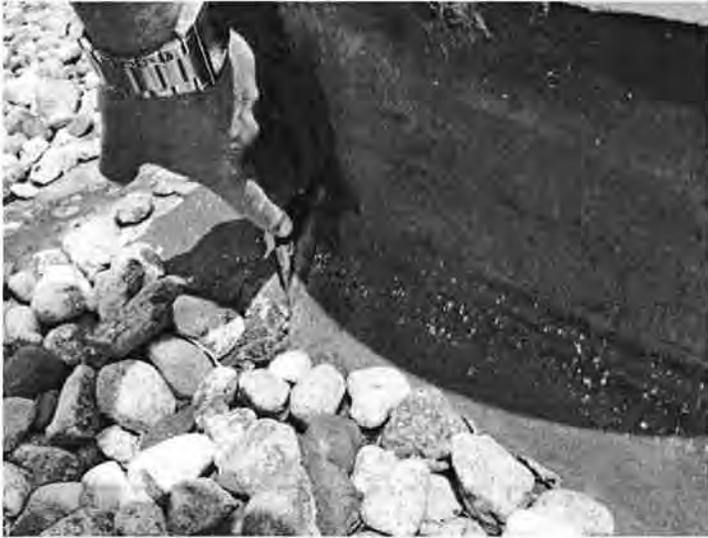
Curbs Corner Detail Open

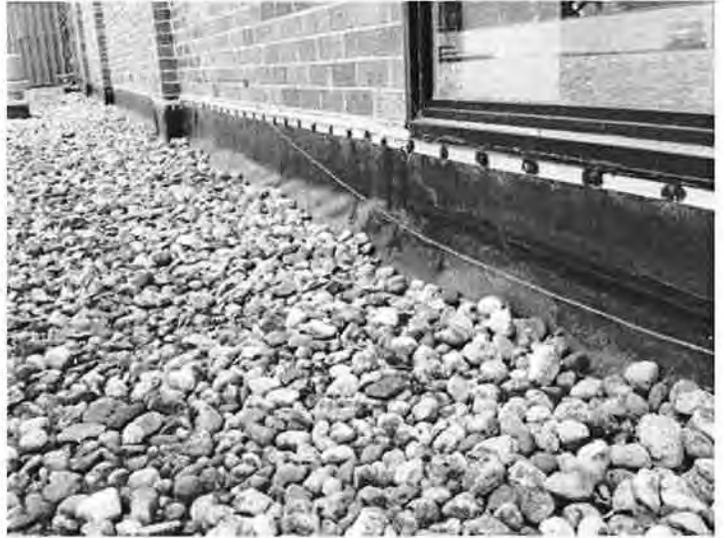
Pulling at Vertical Wall

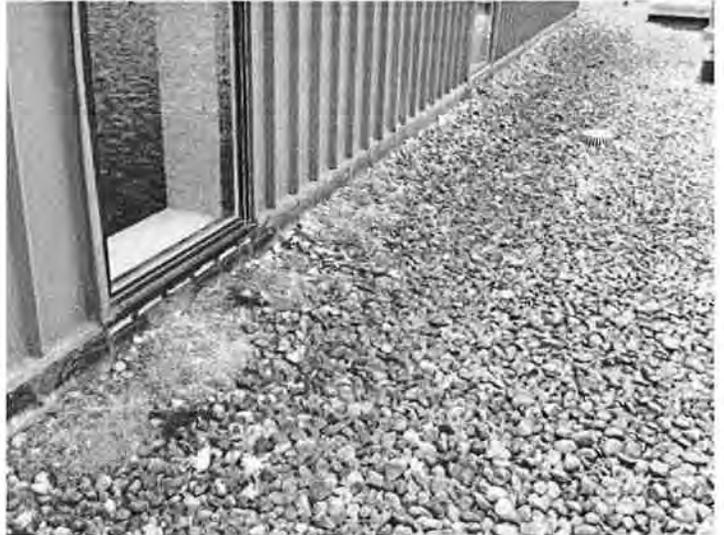
Vegetation Growth At South Shaded Vertical Wall

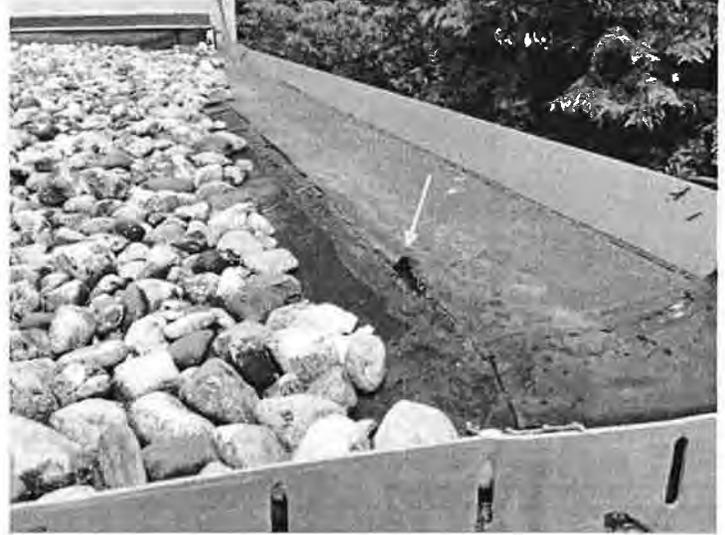
Minor Lifting at Edge Flashing

Section 4 is in good condition. The field is evenly ballasted and free of debris. The flashings are well adhered and performing properly. There is one small area of lifting perimeter flashing.

Section 4: No repairs are needed at this time. The lifted perimeter flashing should be monitored.

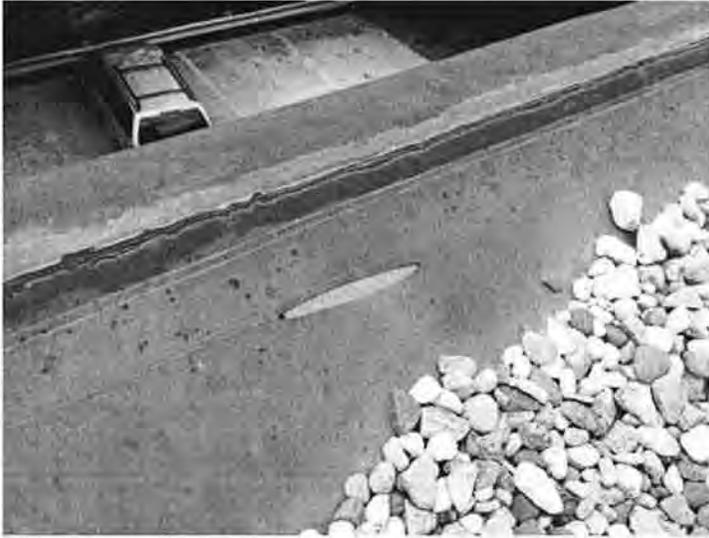
Hole Along West Perimeter Edge

Section 5 is in fair condition. The field is evenly ballasted and free of debris. The flashings are well adhered and performing properly. A hole/tear in the west wall flashing exists.

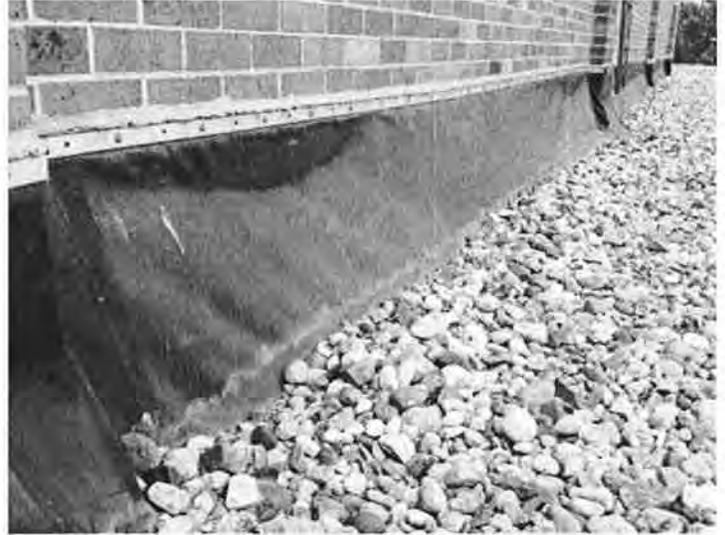
Heavy Pulling at Vertical Wall (70')

Section 6 is in poor condition. The field is evenly ballasted and free of debris. The wall flashings are severely pulling (approximately 70') and moderately pulling (80') on the east. This is typical as the type of roof system ages. There is a hole at a PVC soil stack flashing.

Section 6: The roof should perform approximately 2-4 years after proper repairs have been completed.

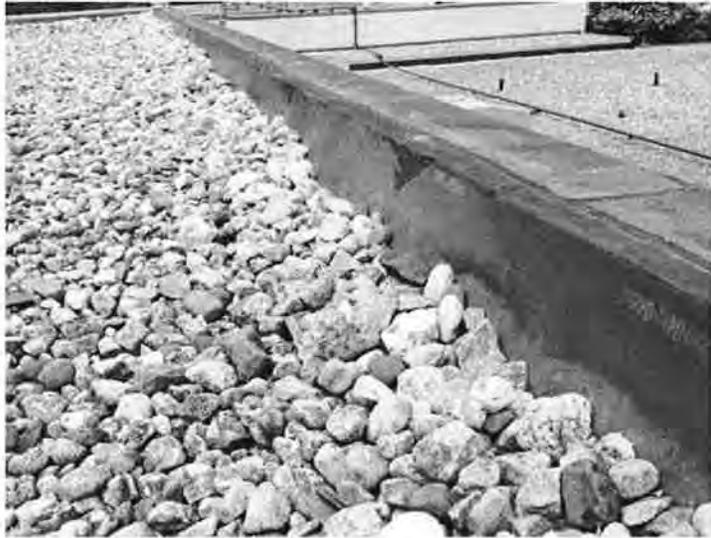
Moderate Pulling Along East Wall (80')

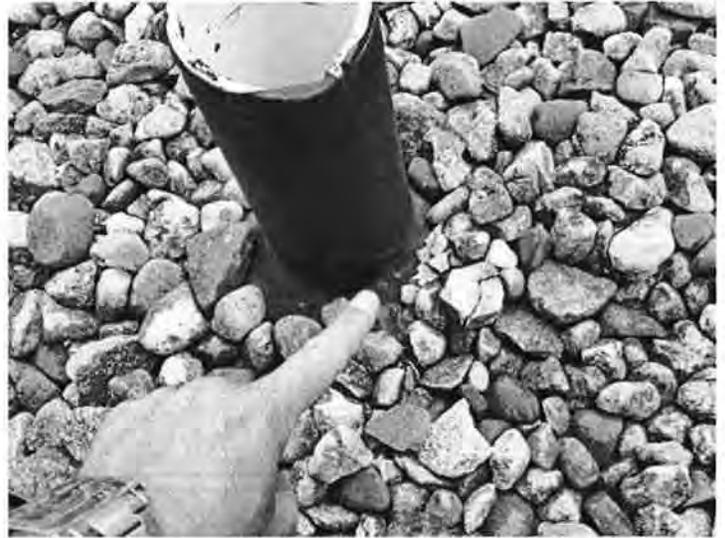
Hole in Penetration Flashing

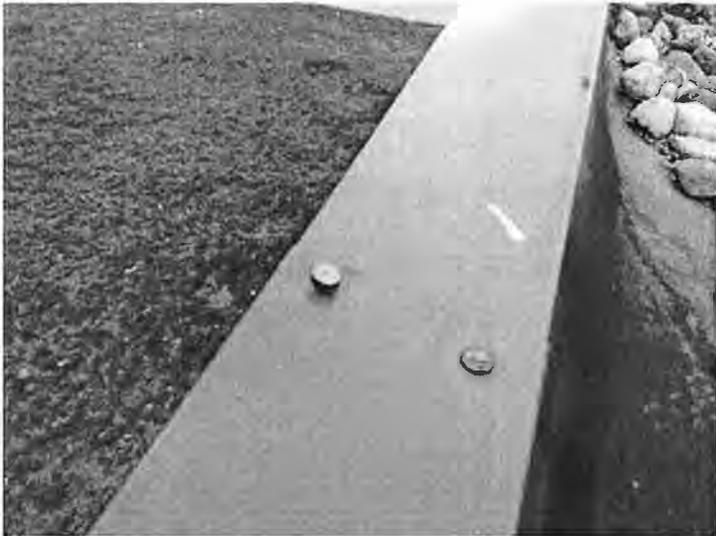
Top Fastened Cap Metal (Poor)

Section 7 is in fair condition. The field is evenly ballasted and free of debris. Overall the flashings are well adhered and performing properly. The cap metal is top fastened in some areas which is a poor detail. The fasteners lift and water can penetrate. There is also a short run of moderate pulling along the east wall.

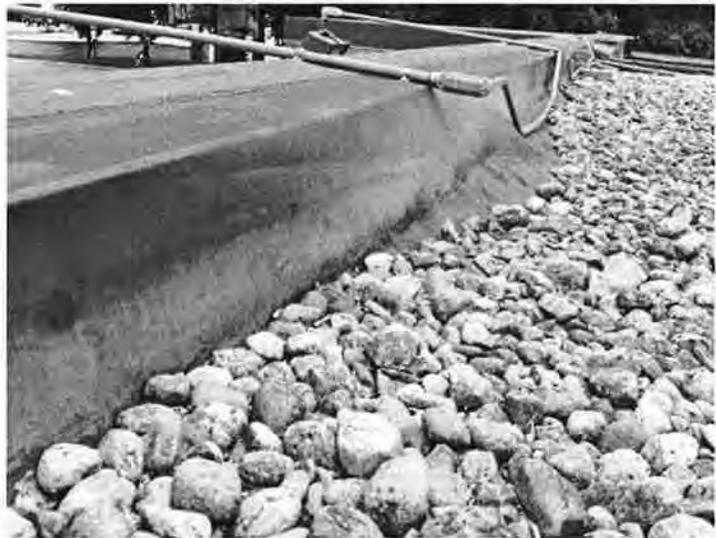
Moderate Pulling Along East Wall (30')

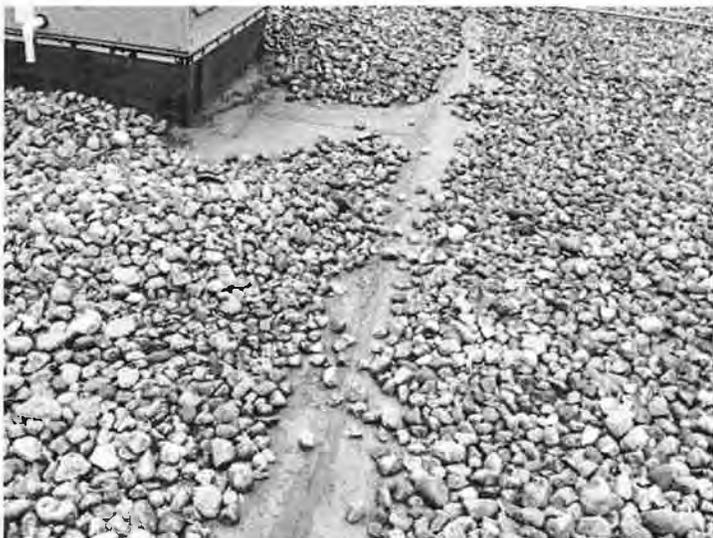
Field Seams Holding But Showing Age

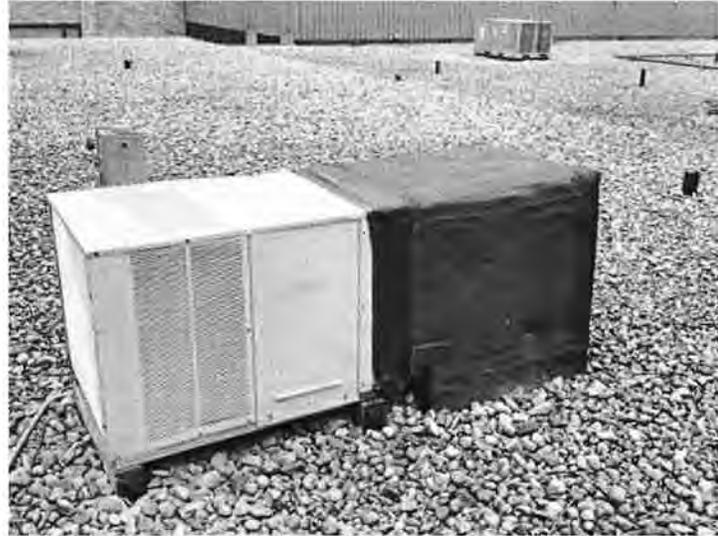
EPDM Wrapped Ducting (Standard)

Section 10 is in fair condition. The field is evenly ballasted and free of debris. The flashings are well adhered and performing properly. A couple HVAC units have been encapsulated with EPDM to likely stop leaks from the non-commissioned units. Minor ponding exists in a few areas.

Section 10: No repairs are needed at this time.
